C-IAUE

Crash Cause Report

Copyright December 2009, Corman Air Park / Gerry Golla

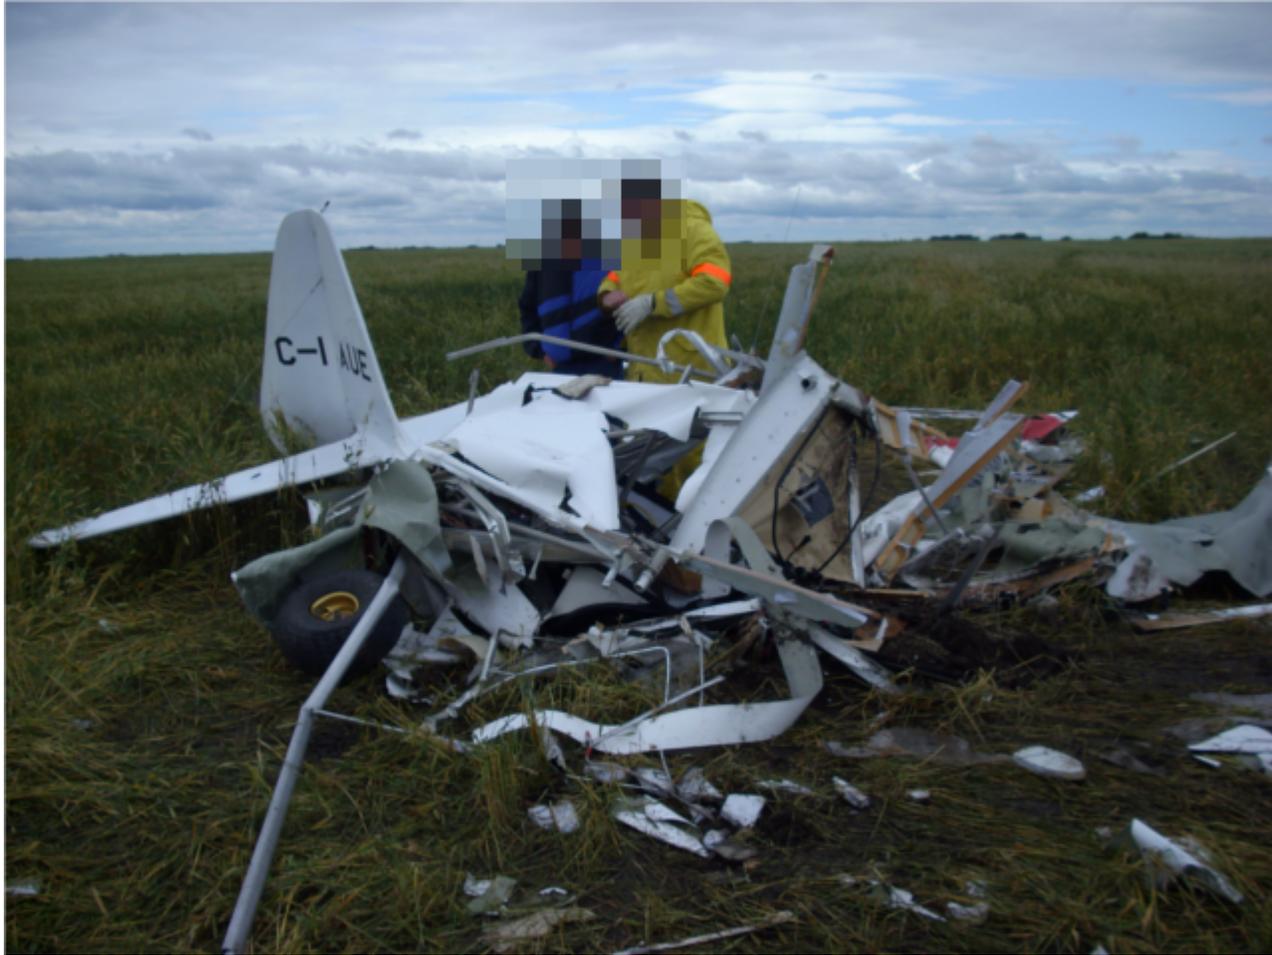
Aircraft As I First Saw It.bmp

The entire fuselage was very badly damaged during impact with the exception of the tail assembly. The forward fuselage was also very badly disturbed by rescue.

The first people on the crash scene have stated that the aircraft as seen in the T.S.B photos, looked nothing like it did before rescue was done with it. I did not get to see the aircraft until T.S.B was finished with it and most of my studies have were done after it was loaded on a trailer and removed from the crash site.

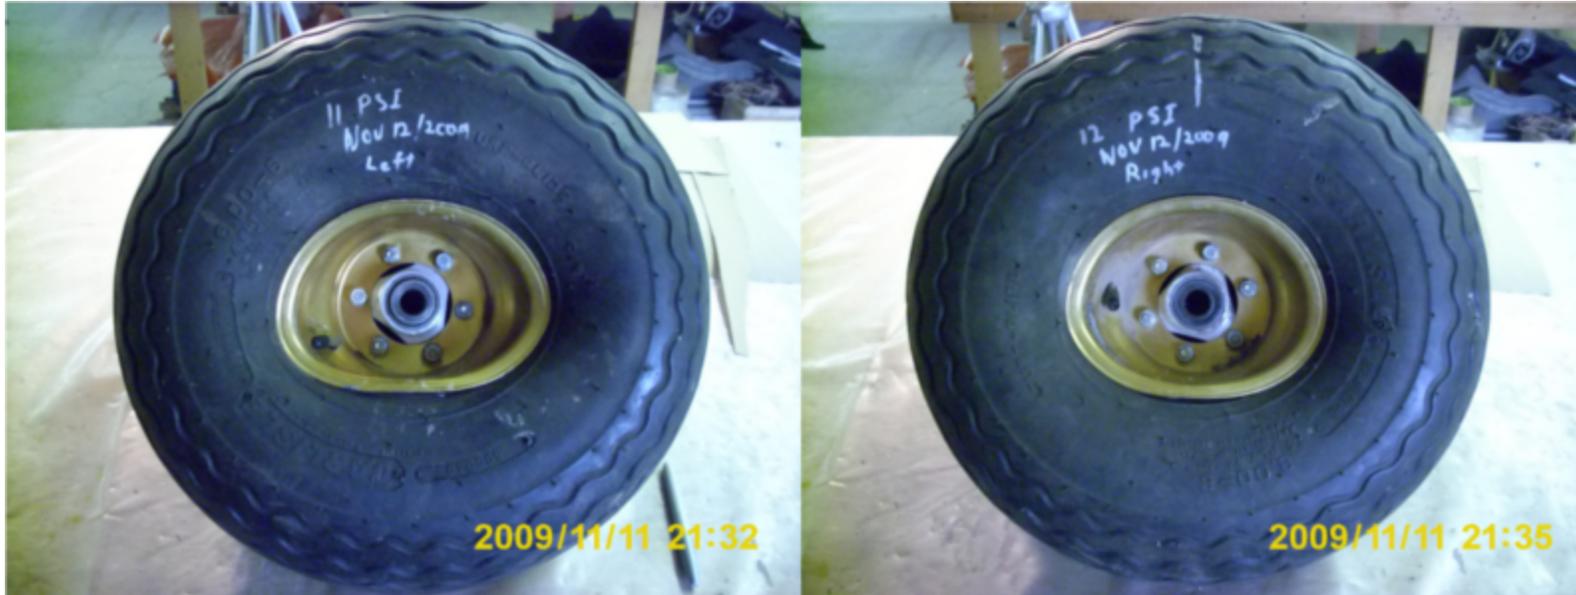
Left-Right Wheels.bmp

It was originally thought that the aircraft must have impacted the ground with the wings almost horizontally level, because both wheels appeared to show approximately the same amount of flattening. This, however has been shown by other evidence not to be the case. The probable explanation for the condition of the wheels is that the wheels and tires weighed several times that of their

Both wheels and tires can be seen below

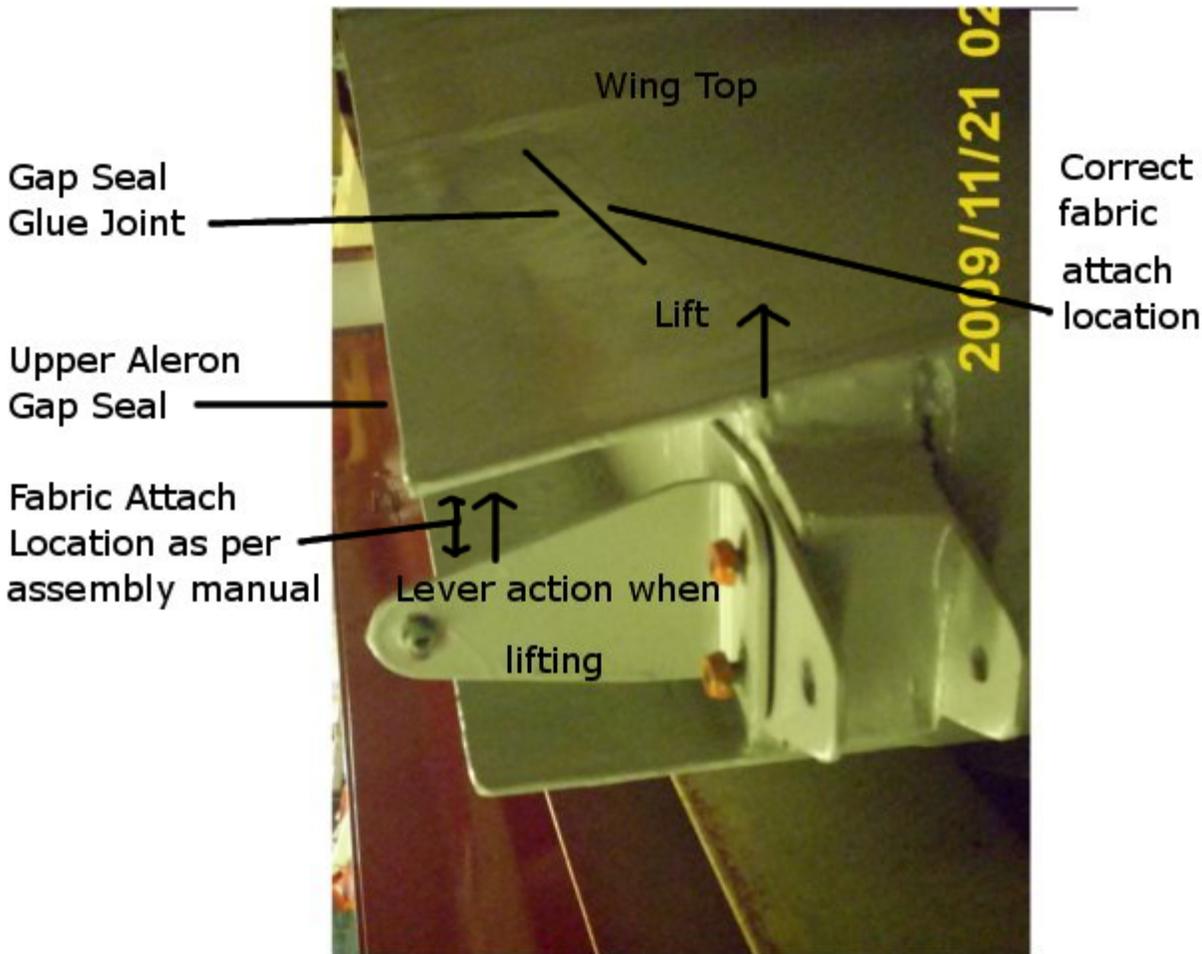
Gap Seal Labeled.bmp

Neither the recommended primer nor rib-stitching was present on this aircraft and the fabric was not attached to the rib caps at all. The recommended method of attaching the fabric to the gap seals has also caused problems with gap seal warpage and partial separations in the past. The fabric on these wings was attached as per the manual, wrapped around the rear edge of the gap seals

and glued underneath. This creates tremendous leverage forces on the gap seal glue joint when the top wing fabric lifts the aircraft. If the fabric is glued to the gap seal just above the glue joint these leverage forces are removed. An important point of note here, if the approved type of primer had been used, the fabric would have effectively been glued to the gap seal in this fashion. This was not covered in the manual.

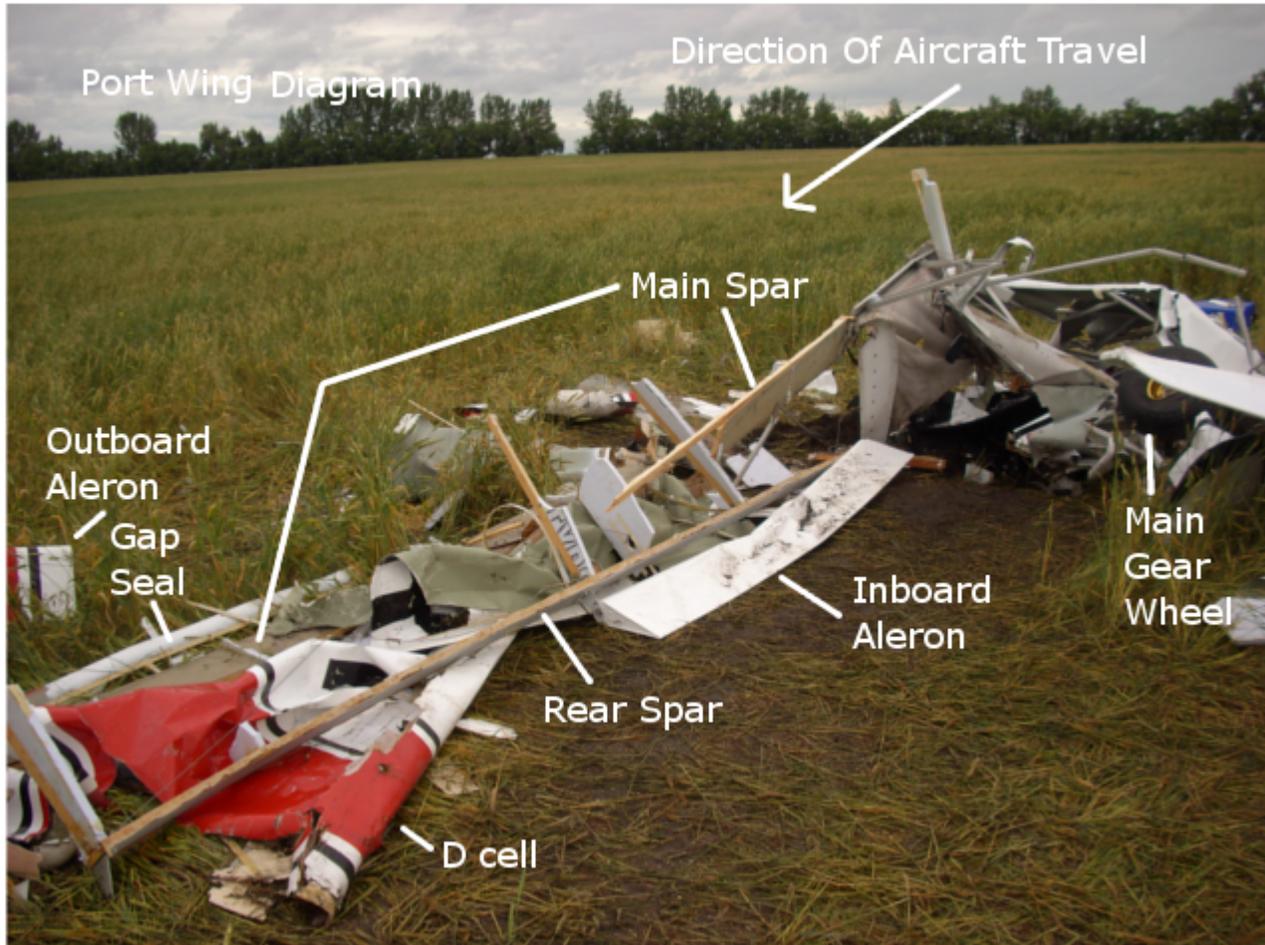
Crash Site Port Wing.bmp

The inboard upper aleron gap seal was found in the field approximately 150 yards due west of the impact site, and pieces of fabric were found between 150 yards west and southwest of the impact site and up to it.

The main spar was broken off about four feet from the wing root at the location of the first shear-web splice block.

The rear spar was broken but remained in one piece except for the gap seals.

The wing struts were moved by rescue workers so their post impact position could not be determined.

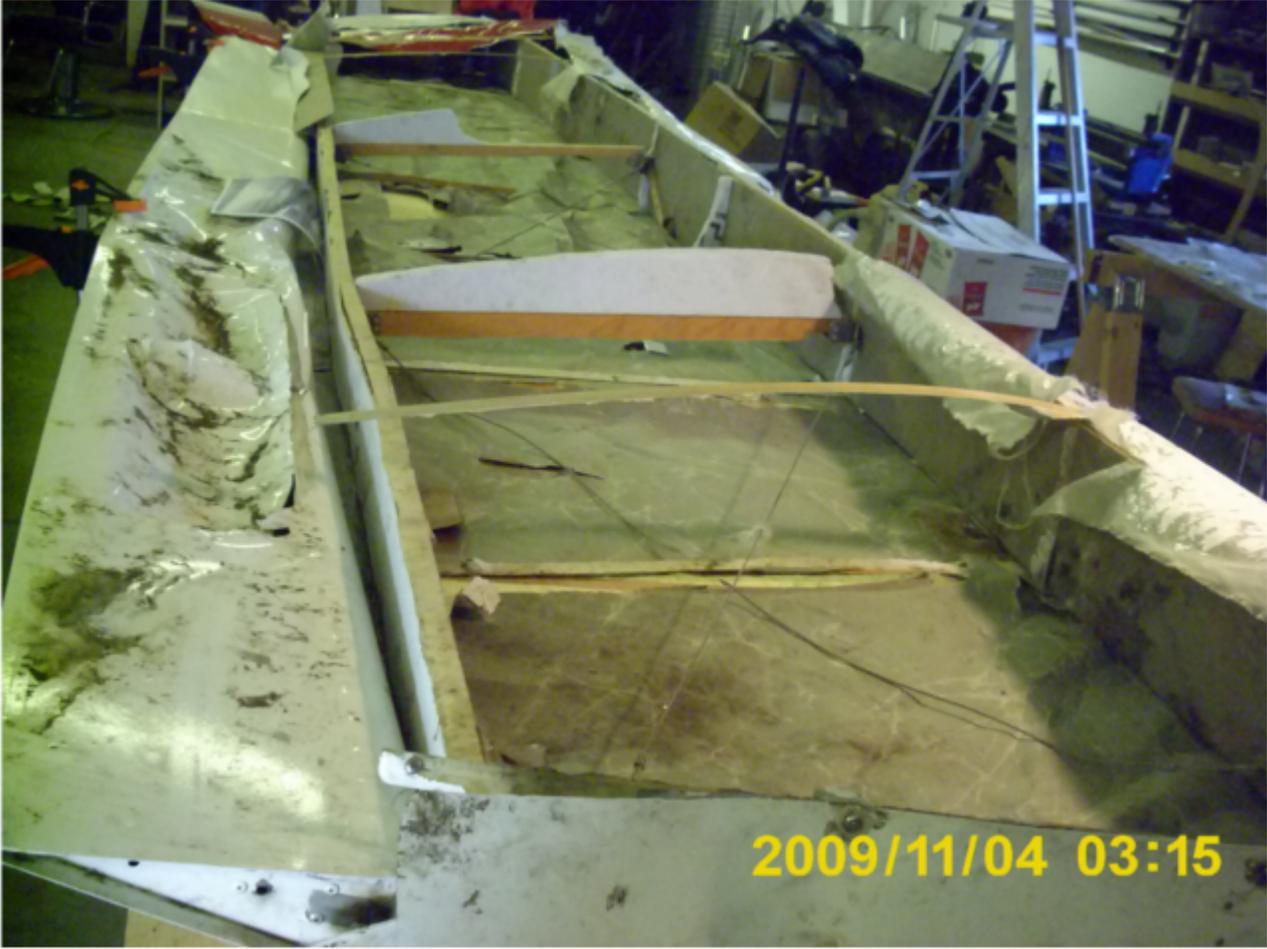
Port Reconstruct Frame.bmp

All of the lower fabric separated from the wing at the impact site.

The wing flattening to the ground and sliding absorbed much of the impact force from this wing, but the tip ground impact coupled with the upper fuselage collapsing forward as the engine impacted transferred large rearward forces down the wing, breaking compression struts and the inboard drag cable. The rear spar developed an S bend fracture near the root as a result of the rearward force of the wing tip being transferred down the spar trying to compress it. The S bend is clearly visible in the photo 'Port Reconstruct Frame.bmp' shown earlier.

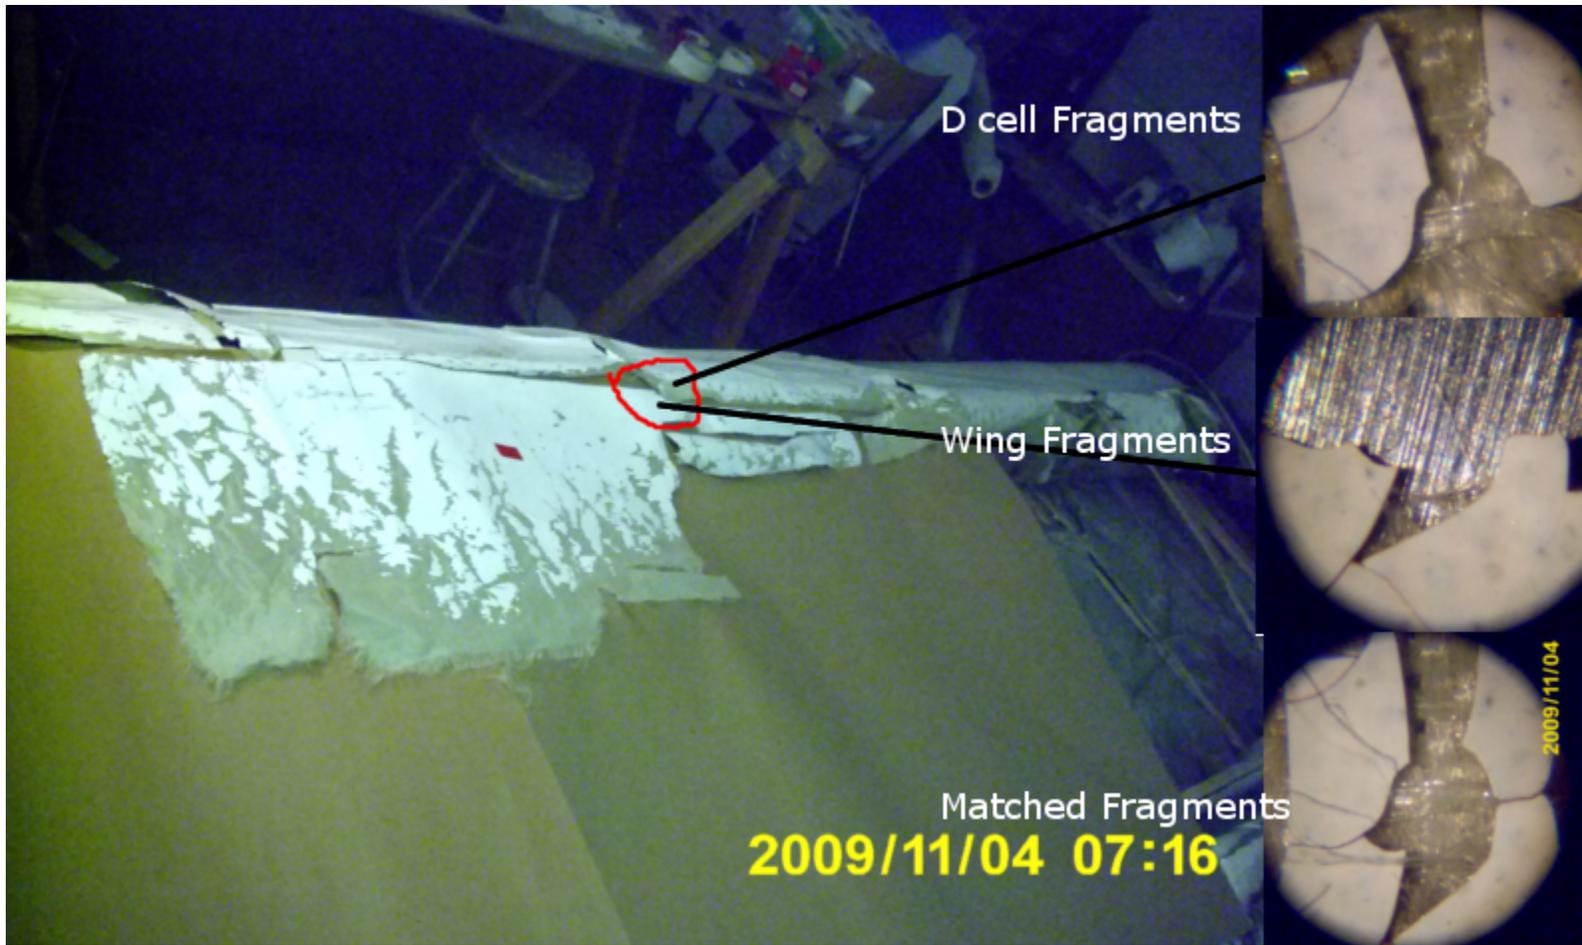
Microscope Match.bmp

Placement of the upper fabric was initially difficult to establish, because of damage to the fabric edges, but a paint chip match was established using a microscope.

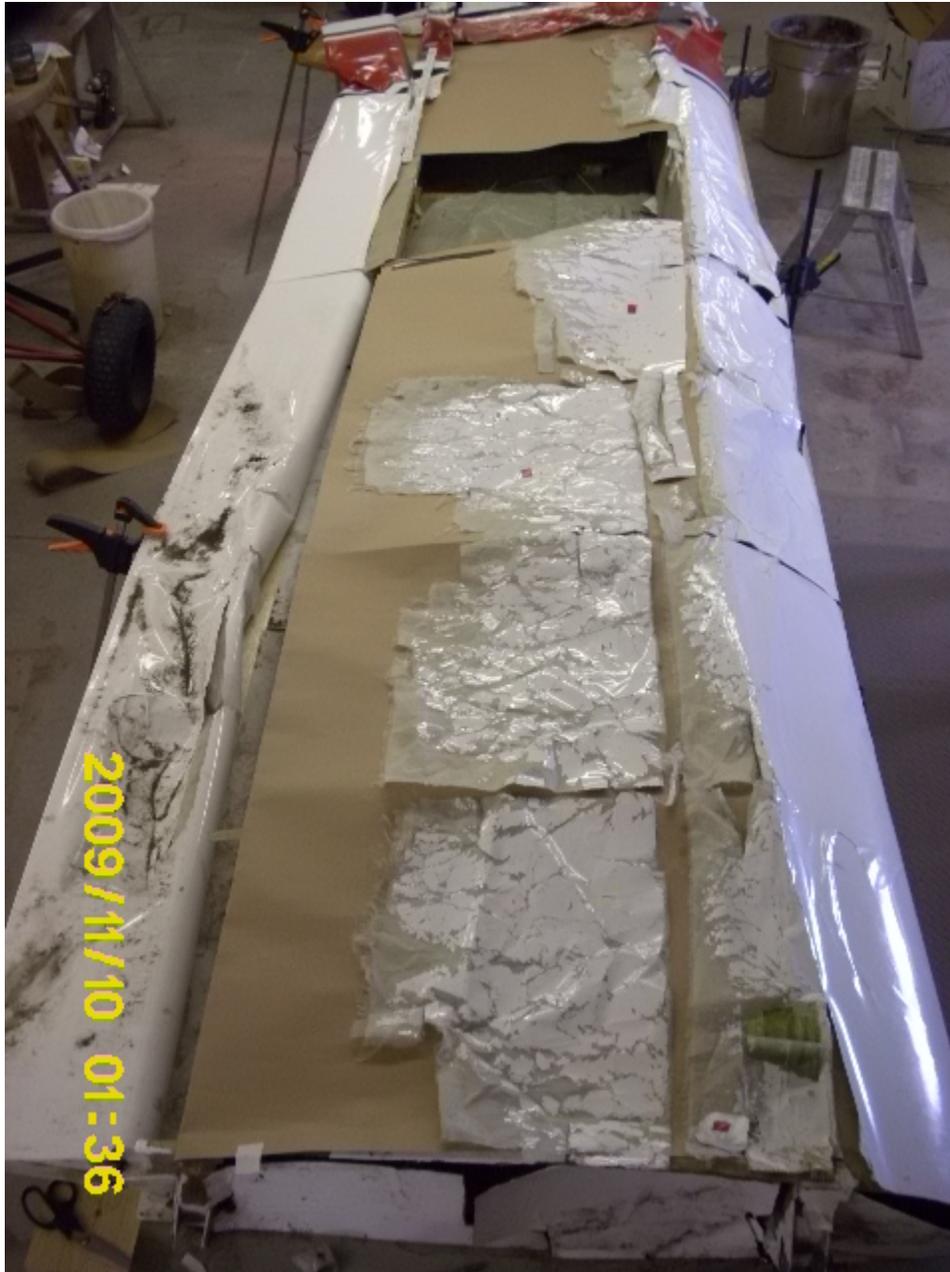
Root Fabric.bmp

As can be seen in the following photo, except for a section near the wing tip that can not at this time be accounted for (T.S.B. may have some of these pieces) almost all of the upper wing fabric shows significant flaging which would indicate that the upper wing fabric was torn during flight. This would mean that all of the upper port wing lift would have been lost.

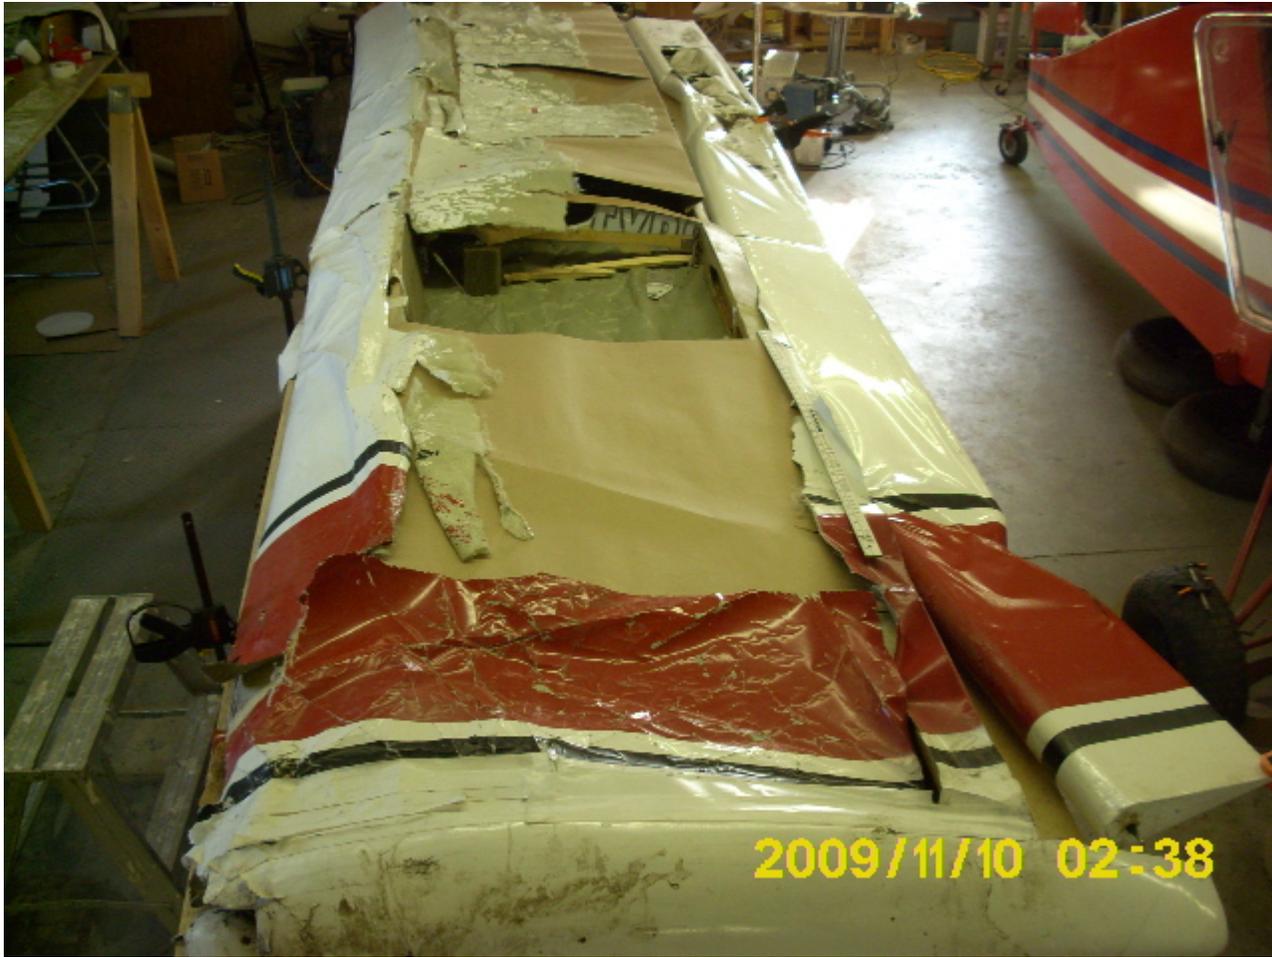
Tip Fabric.bmp

The pieces of fabric with red tape patches were found out in the field. The rest were found at the impact site. Except for a very small piece of fabric at the tip no matches were made for pieces attaching to the top rear aleron gap seal.

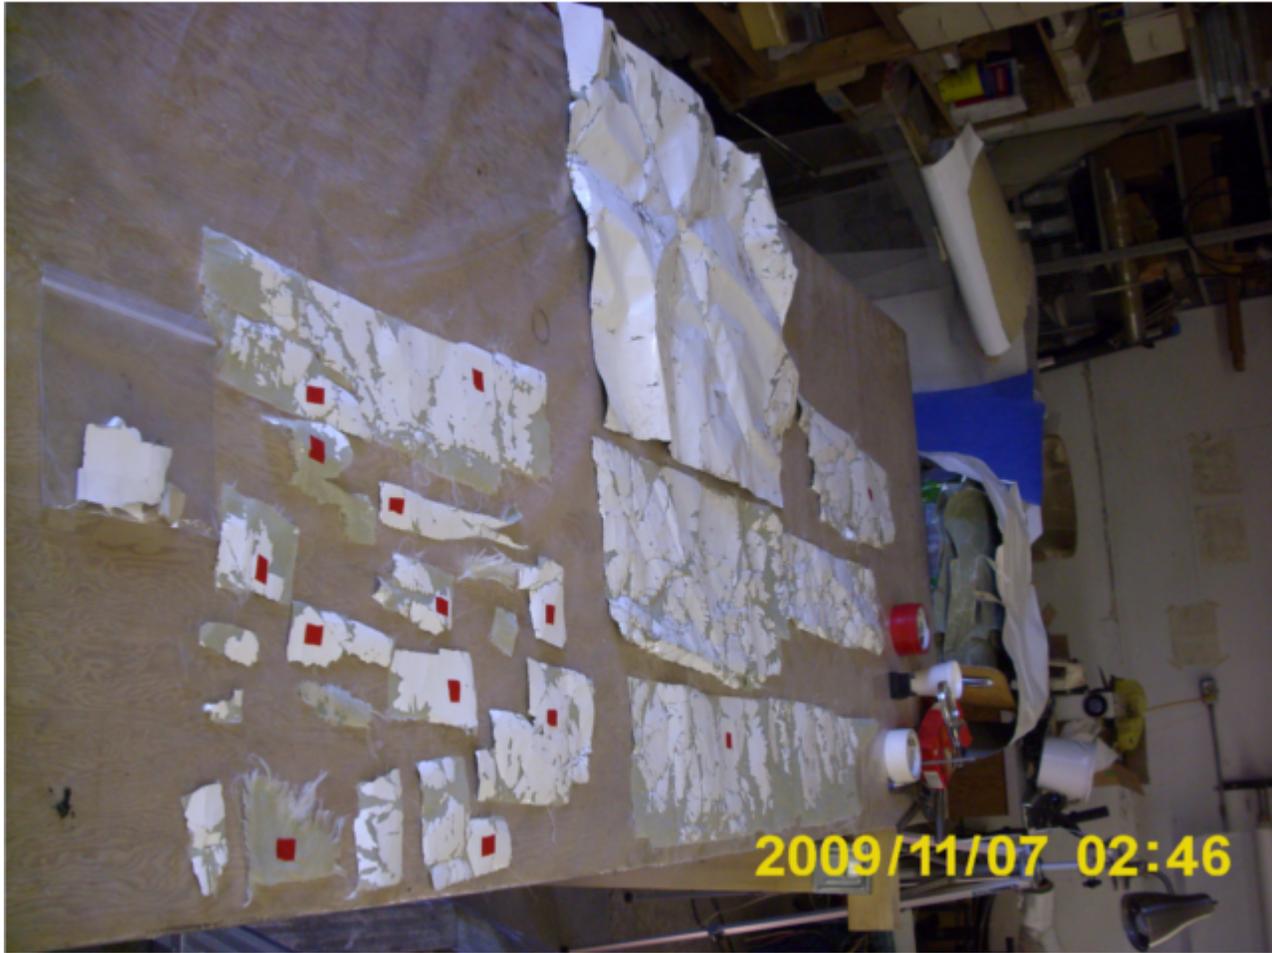
Unplaced Fabric.bmp

We still have quite a bit of fabric that cannot be placed at this time. The large pieces shown below, can be verified to be from a wing by the indentations left by the wing ribs. Again the pieces marked with red patches were found out in the field. The very small unmarked pieces on the left were also found in the field. The rest was found at the impact site.

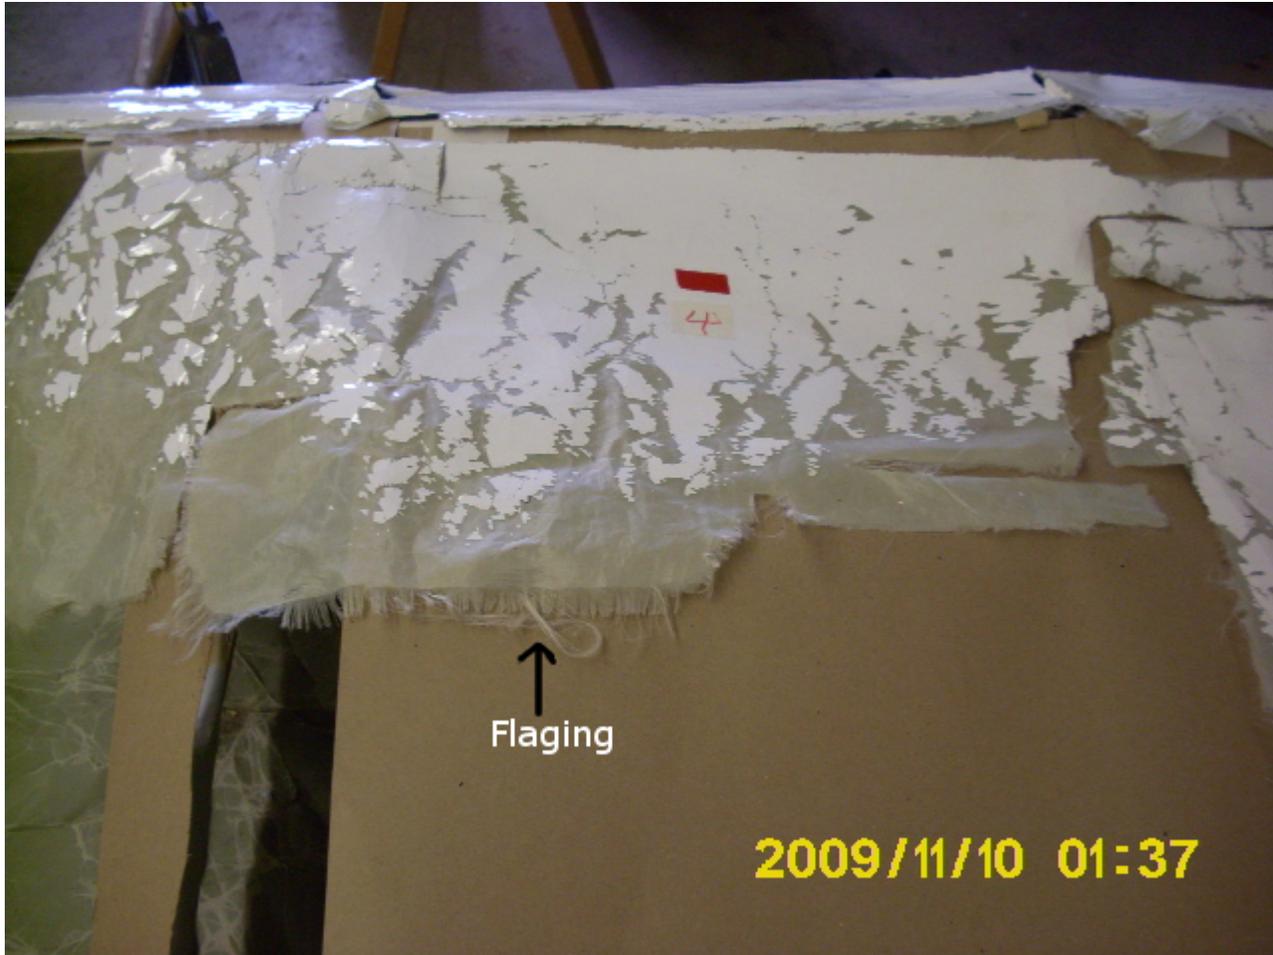
Flaging.bmp

A lot of the fabric on this wing top shows serious 'flagging'. This occurs when the edge of a piece of woven fabric is exposed to violent turbulent airflow. It shreds like the end of a flag exposed to very strong winds.

It should be noted that all of the pieces of fabric that we found in the field showed flagging. This may or may not be true of those found by T.S.B., however, I saw only a very few pieces that showed this phenomena when I was there, as far as I know the location of those pieces has never been determined and there is a very high probability that they are from the left wing.

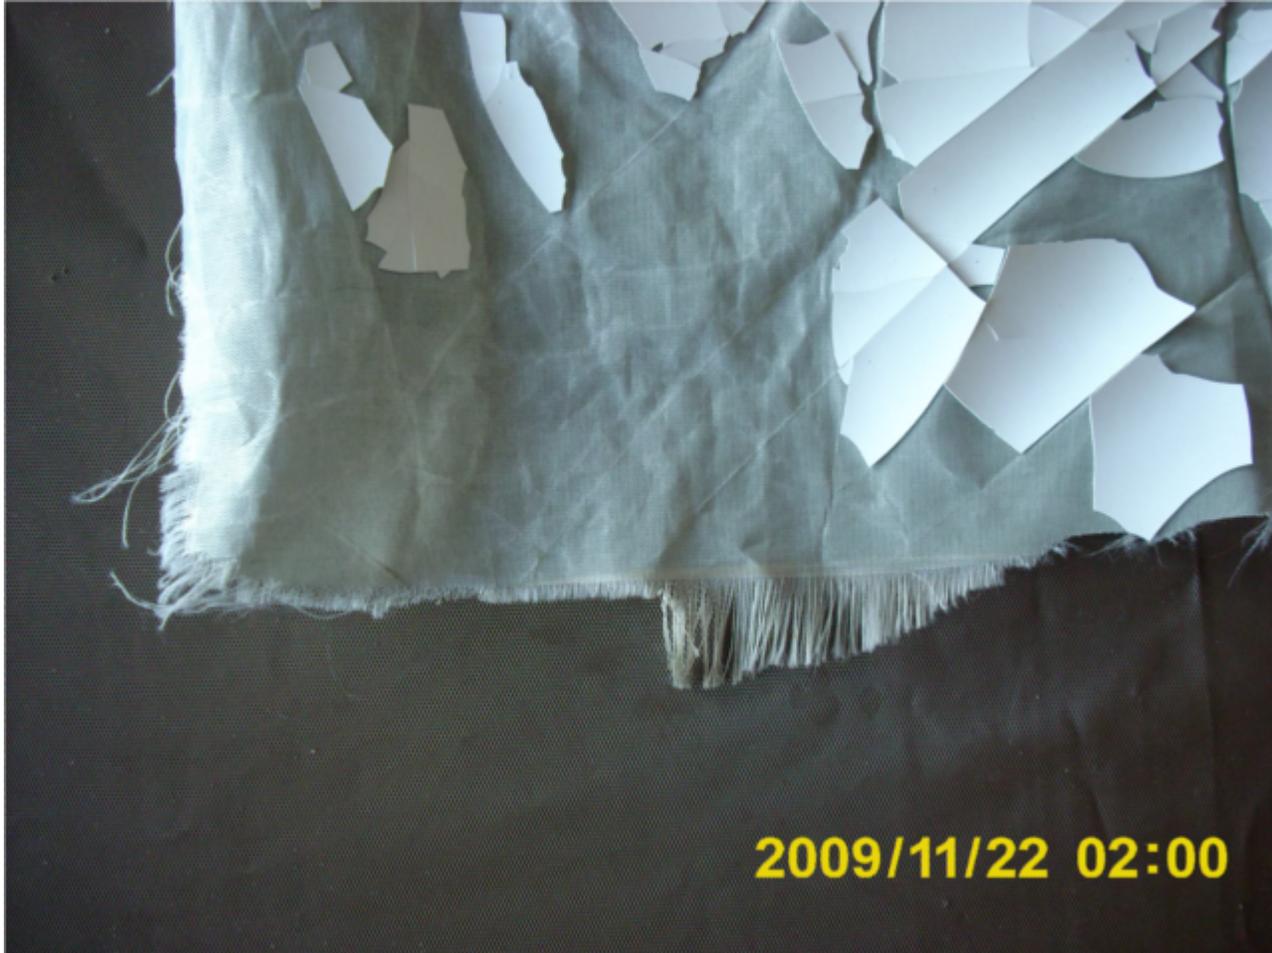
Fabric Test Sample.bmp

Unfortunately, the track proved to be too short to achieve significant exposure times at high speeds and the test results were inconclusive. They show only that significant flaging would appear to take more than just a few seconds, higher speeds, greater turbulence, or a combination of all of these.

The following photo shows a test sample that reached a peak speed of 90 mph starting at approximately 70 mph over a time span of about 20 seconds. The edges started as free hand tears.

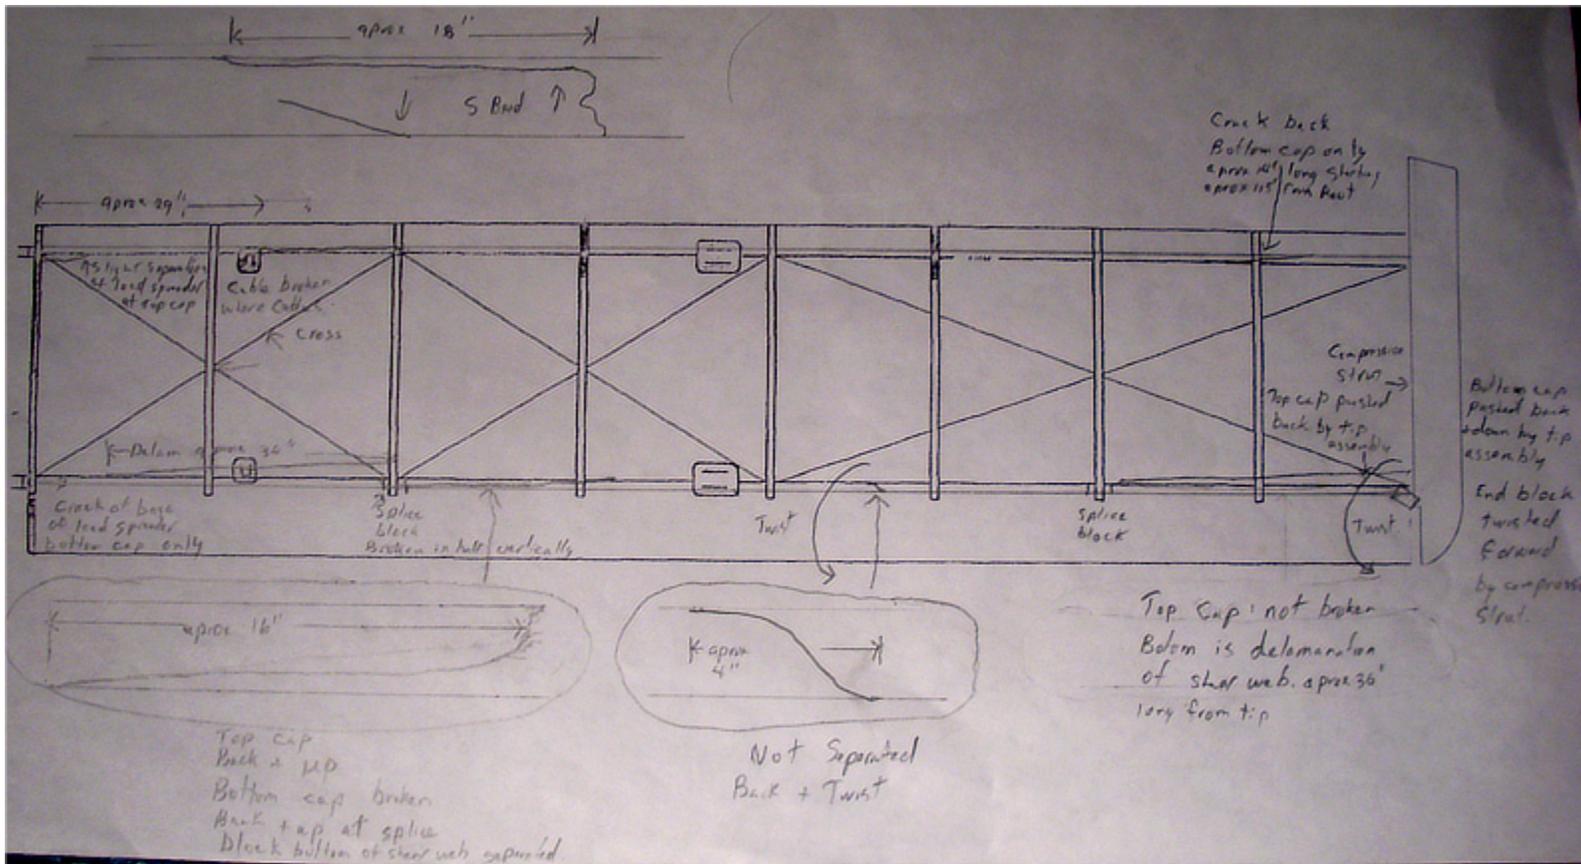
Break Drawing.bmp

The following sketch was done during the reconstruction and shows the approximate location of the spar breaks. It was drawn in pencil, so it is a bit hard to read.

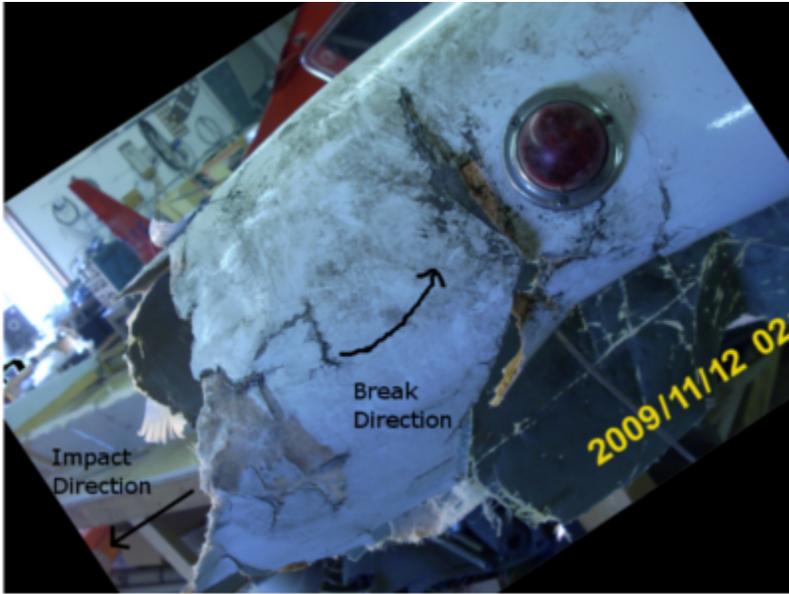
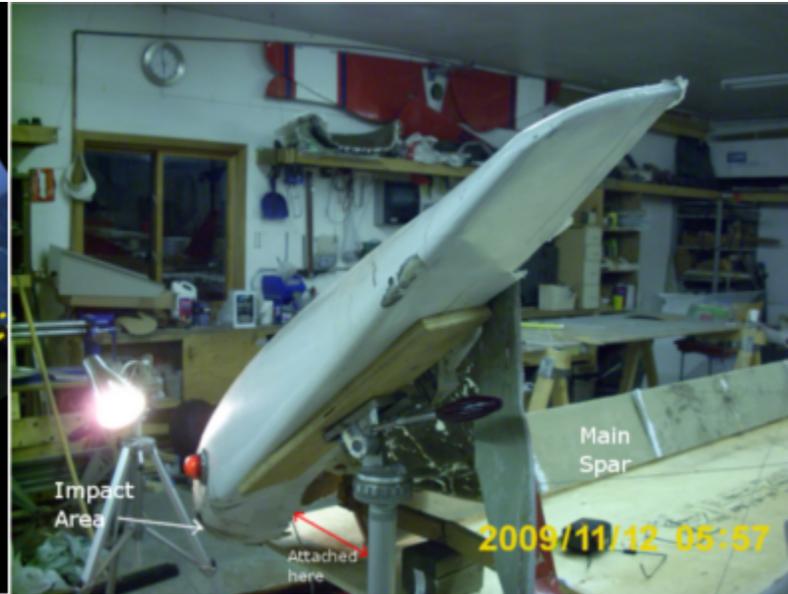
Tip Composite.bmp

The fiberglass composite wing tip had a large piece broken from the tip front top.

Examination of the fractures show that it broke up and back.

The following tip photos show the breaks and the approximate angle the tip would have impacted the ground to have caused them.

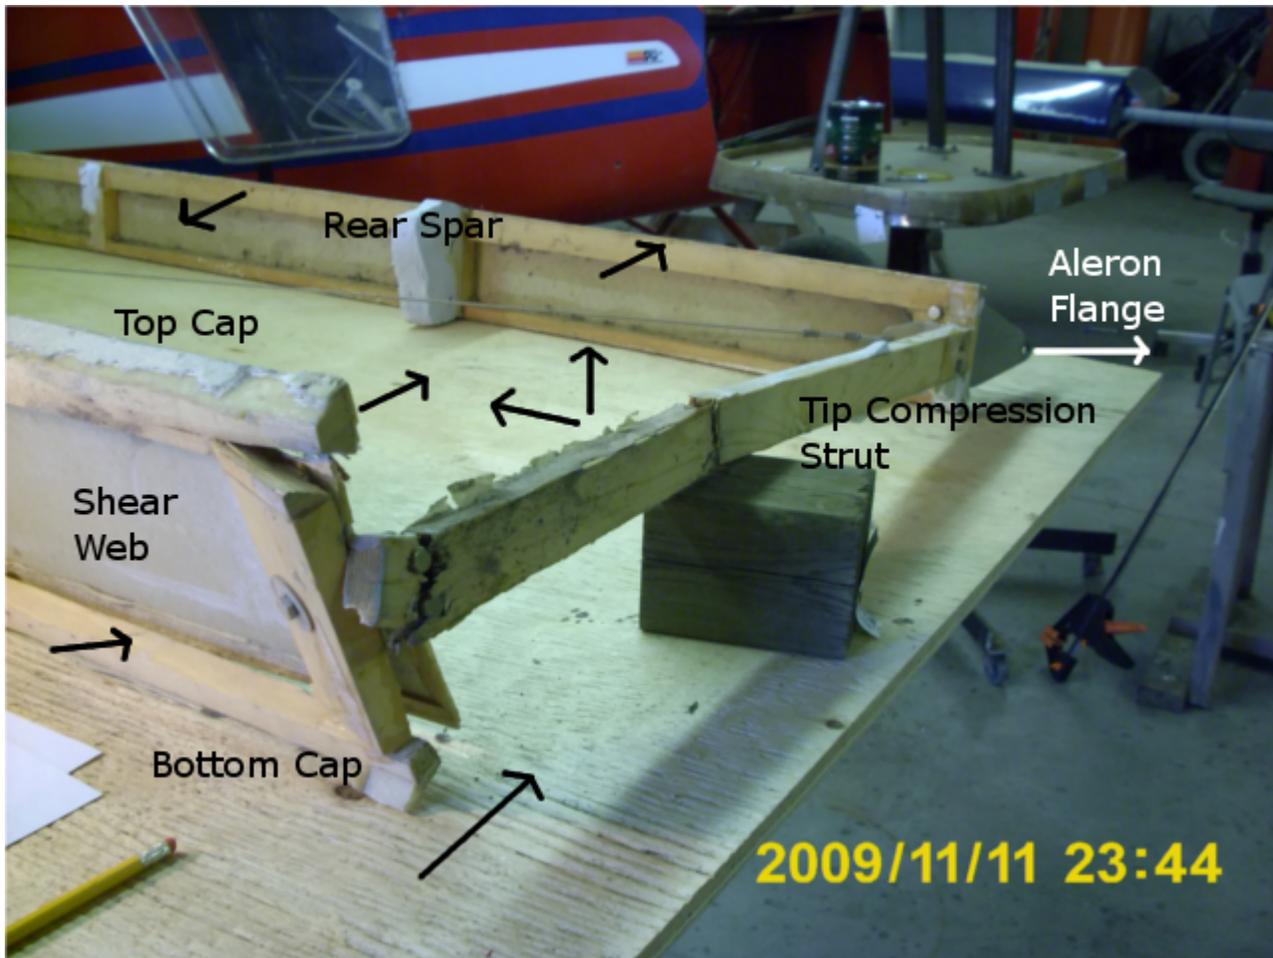
Tip Frame.bmp

The tip compression strut was broken in compression at the front attach bolts and also approximately 10 inches back from these bolts. It was broken upward and inward toward the root. The rear spar tip end was pushed back and against its drag cable causing the section inboard of the tip to bend back. This is most likely when the tip upper and lower aleron gap seals separated at their respective glue joints. The composite tip assembly completely separated from the wing taking a small section of upper fabric with it. The direction of these fractures are shown in the following photo.

The twist of the main spar would have been greater than is shown in the photo. It would be closer to the angle of the short piece of the compression strut still attached to the main spar.

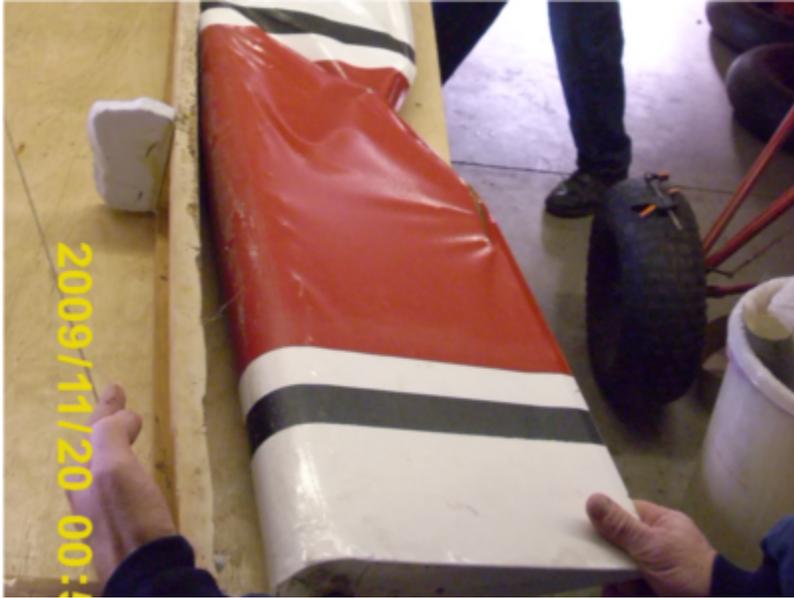
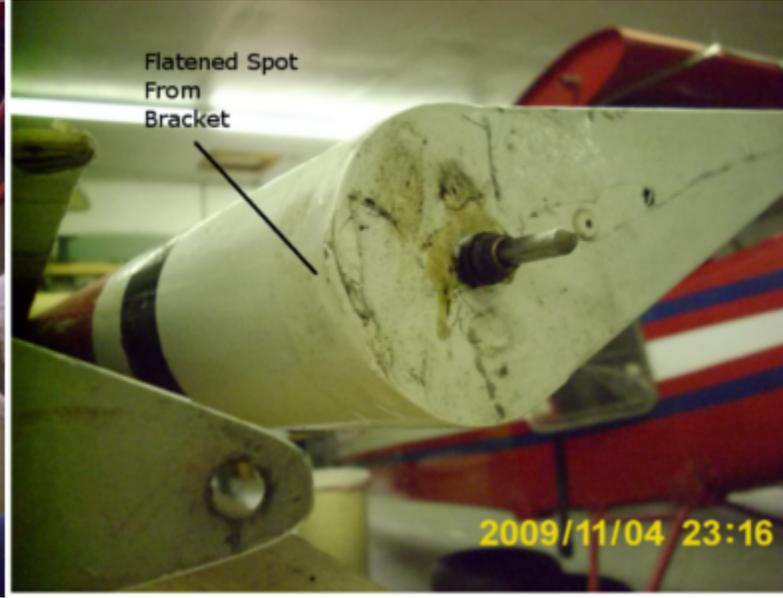
Aleron Composite.bmp

The bend in the rear spar caused the outboard aleron to kink at the bend in the spar and also pressed the rounded end of the aleron against the aleron bracket, as shown in the following photos.

There was a splinter crack in the bottom rear spar cap that is approximately 14 inches long at about the center of the aleron red section. The crack corresponds with the rear spar being twisted in a clockwise direction (as viewed from tip) as the rear spar was being bent back against its drag cable. This twisting motion corresponds to the tip compression strut being pushed upward at its center compression break.

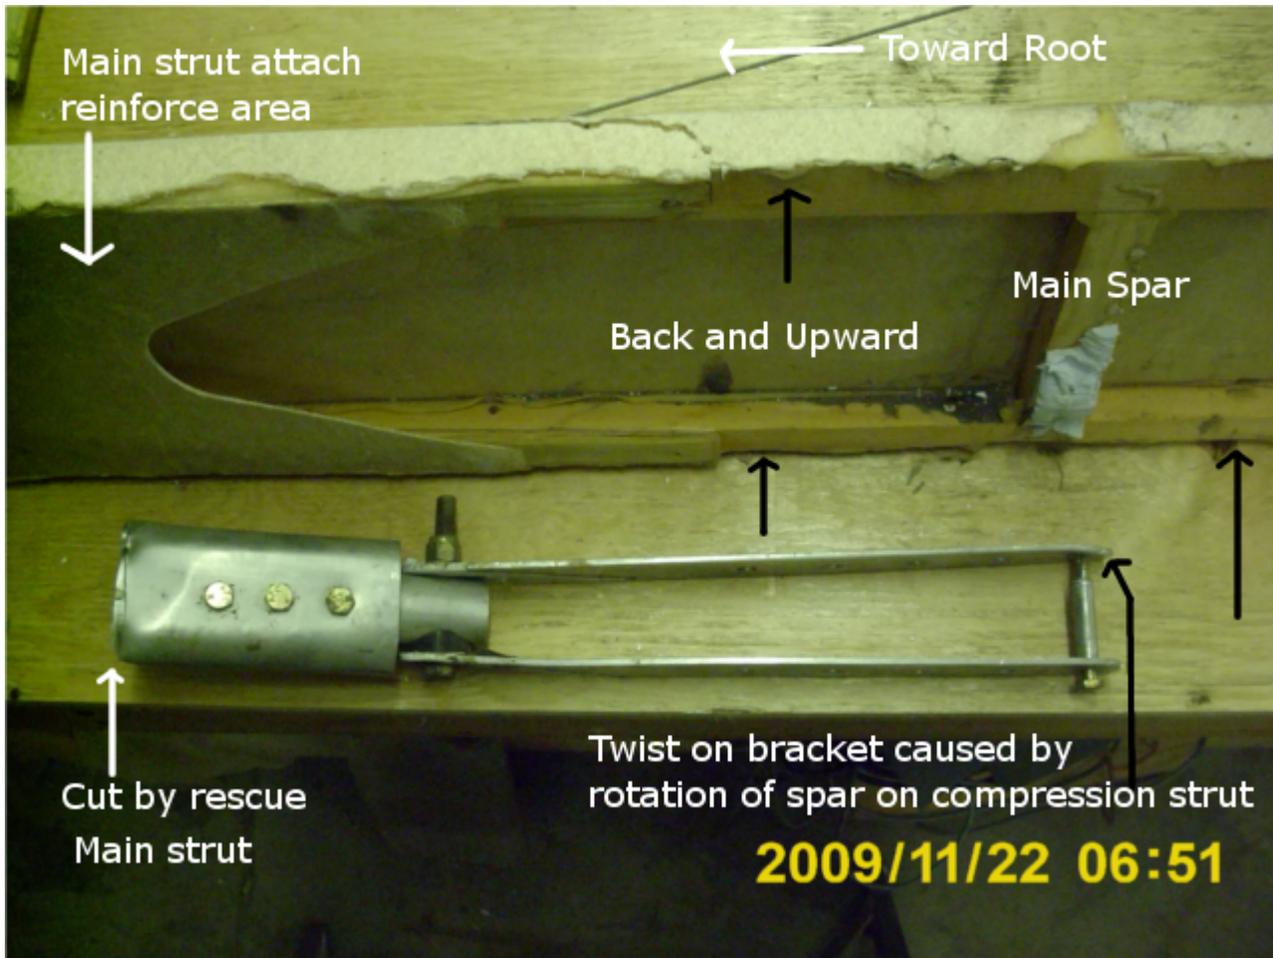
Center Main Spar Break.bmp

The main spar was also broken just outboard of the main front strut attach point reinforcing area. There is a splinter break in the bottom cap and a compression break in the top cap although the breaks did not separate. This would indicate that the spar broke here while being pushed back and upward as it was being twisted CLOCKWISE from the bottom as viewed from the tip. The bend in the end attach bolt and bracket that was attached to the compression strut bracket between the front and rear spar at this point would also indicate the clockwise twisting motion of the main spar.

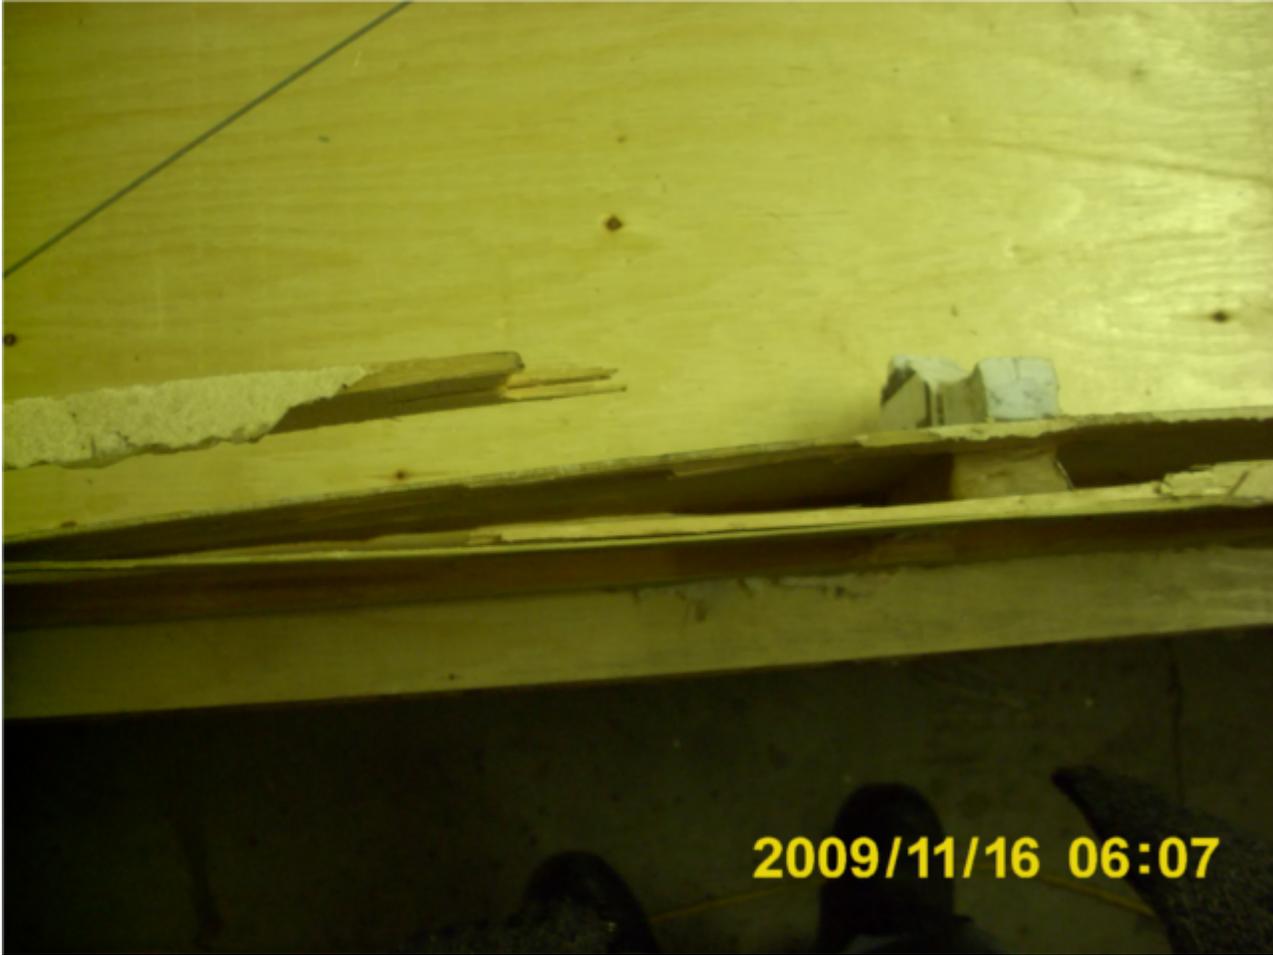
Main Break.bmp

The main spar separation break shown in the following photos occurred approximately 4 feet out from the root and consisted of a very long splinter break in the top cap about two and one half feet in length stretching from the shear web splice block to the main strut attach point. There is a break in the bottom cap that can be seen to have been broken back and upward around the bottom of the shear web splice block as referenced from the tip end of the spar to the root end. The shear web splice block was also split in half vertically 90 degrees to the spar.

Above is a partial view of the long splinter break. Below is shown the broken splice block and the lower break.
