C-IAUE

Crash Cause Report

Copyright December 2009, Corman Air Park / Gerry Golla

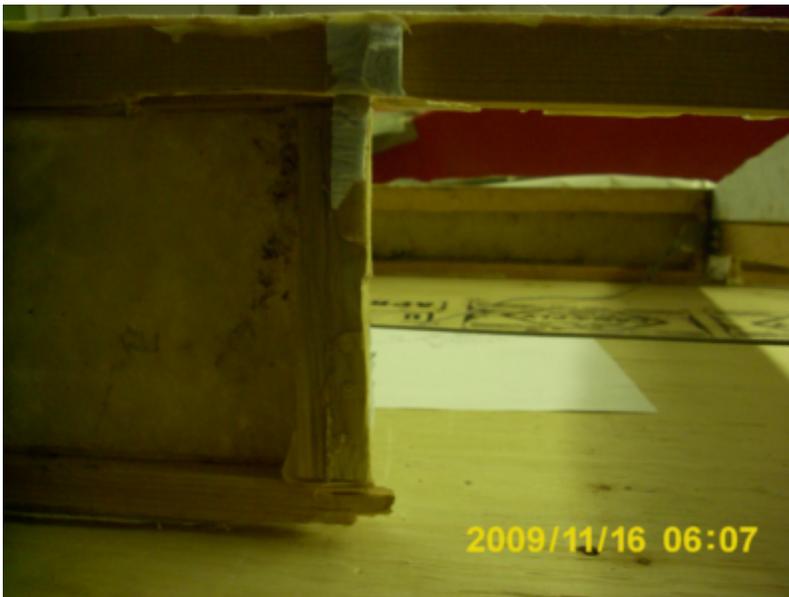
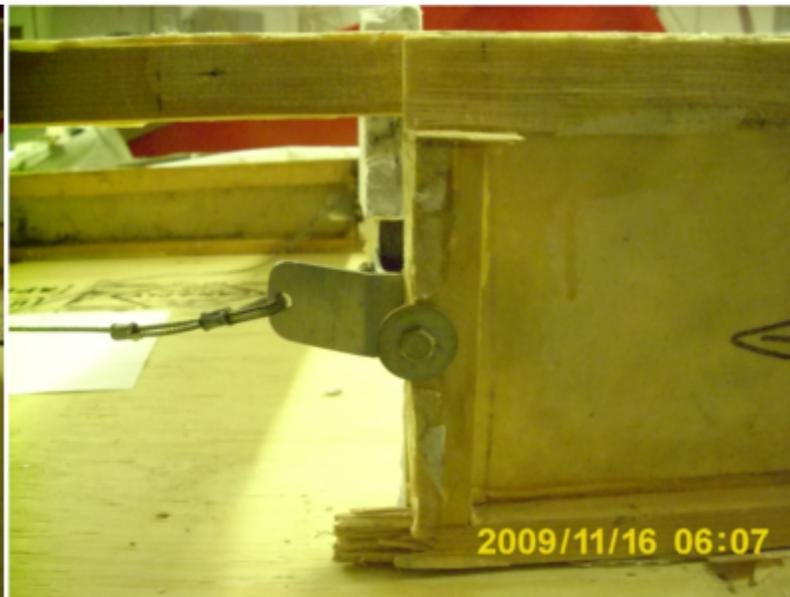
Main Spar Separation Break L-R.bmp

Above is a partial view of the long splinter break. Below is shown the broken splice block and the lower break.

These breaks also show twisting in a CLOCKWISE direction as viewed from the tip

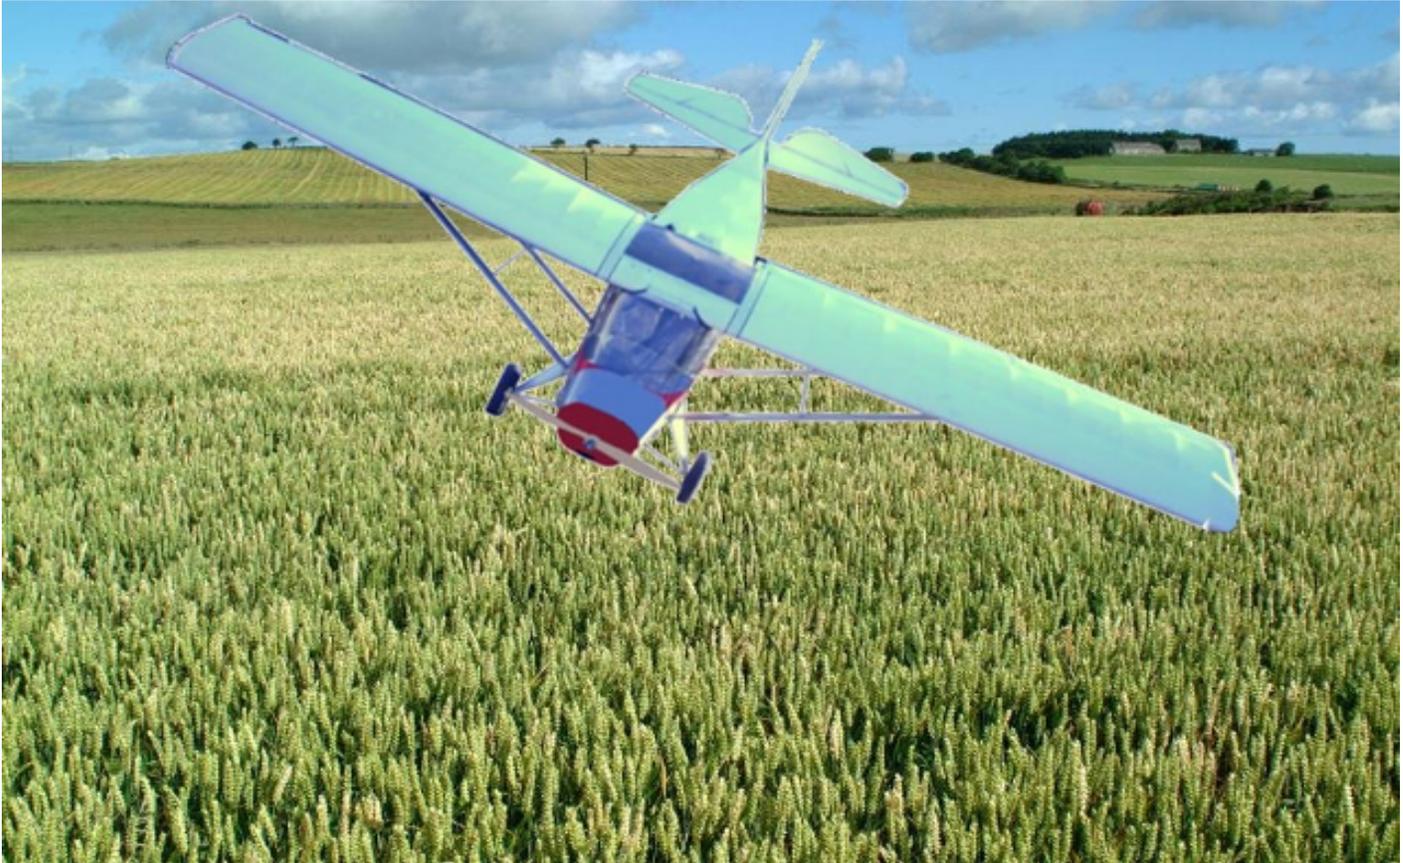
Pre Impact.bmp

The above composite photo approximates the most likely attitude of the aircraft just as it struck the ground as supported by the evidence of the wreckage.

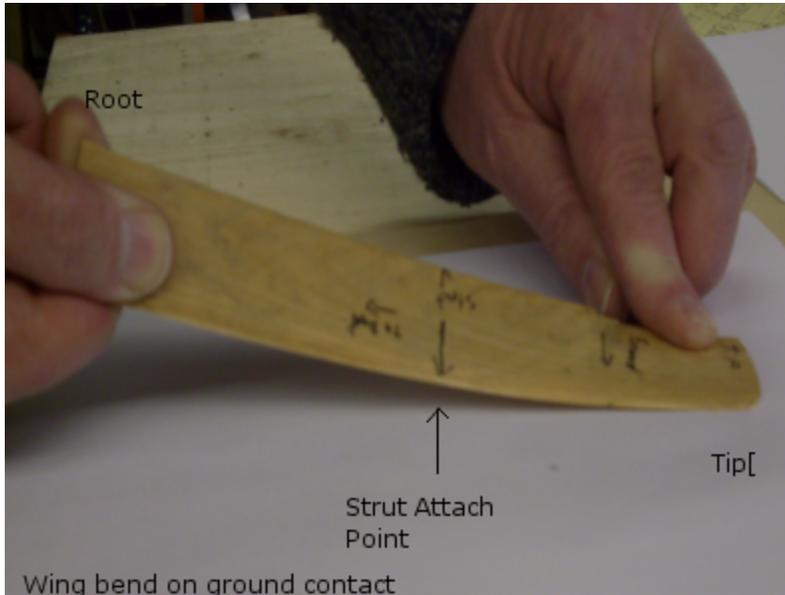
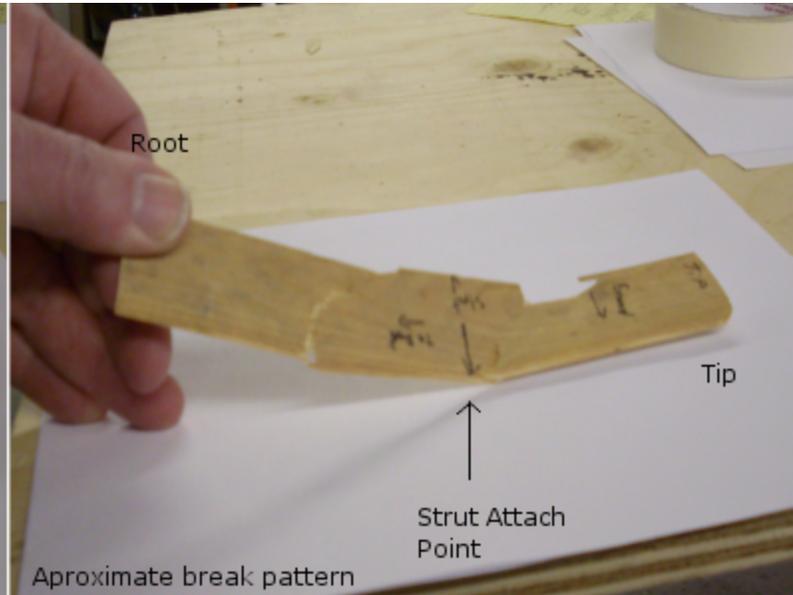
Wing Bend_Break.bmp

The outboard section of the wing would then have started to flatten against the ground as shown below left. This would cause a clockwise twist of the outboard wing section (as viewed from the tip) as related to the inboard section.

The support of the main strut would tend to cause the fracture outboard of the main spar reinforcement area and due to leverage would cause a much greater force to be transferred in to the inboard side of the reinforcement area where the spar failed and separated.

The tip compression strut forced the outboard end of the rear spar against that sections' anti-drag cable causing the rear spar to bend inwards toward the front spar kinking the outboard aleron (see 'photo Aleron Composite.bmp'). The following photos show how the wing would break and bend as it impacted the ground.

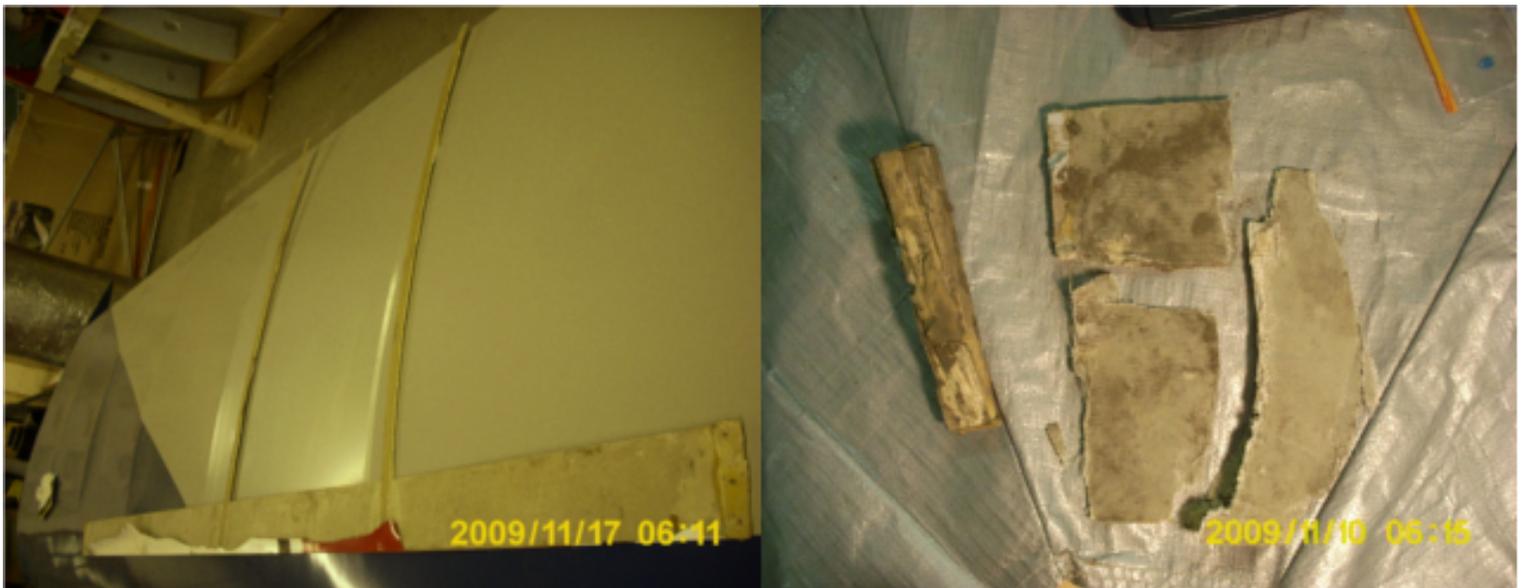
Starboard Wing US Located.bmp

These included the outer upper aileron gap seal from starboard wing, (they had the one from the port wing) and most of the pieces missing from the main spar break. These are shown below. The gap seal is on the left, it is sitting on top of a finished wing.

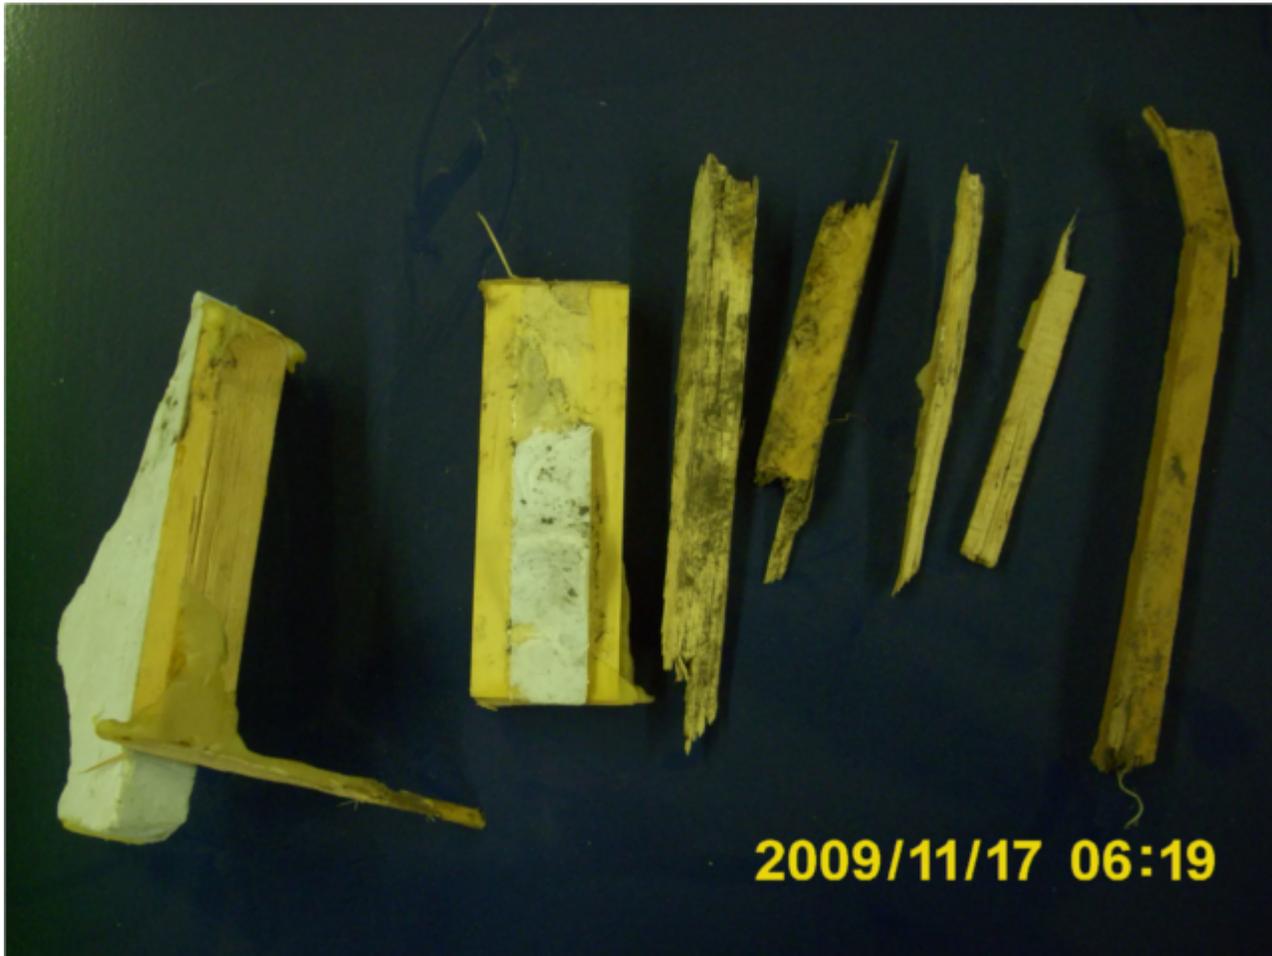
Non Port Wing Parts.bmp

deduced that these pieces must be from the starboard wing. They were forwarded to T.S.B. and are shown in the photo below.

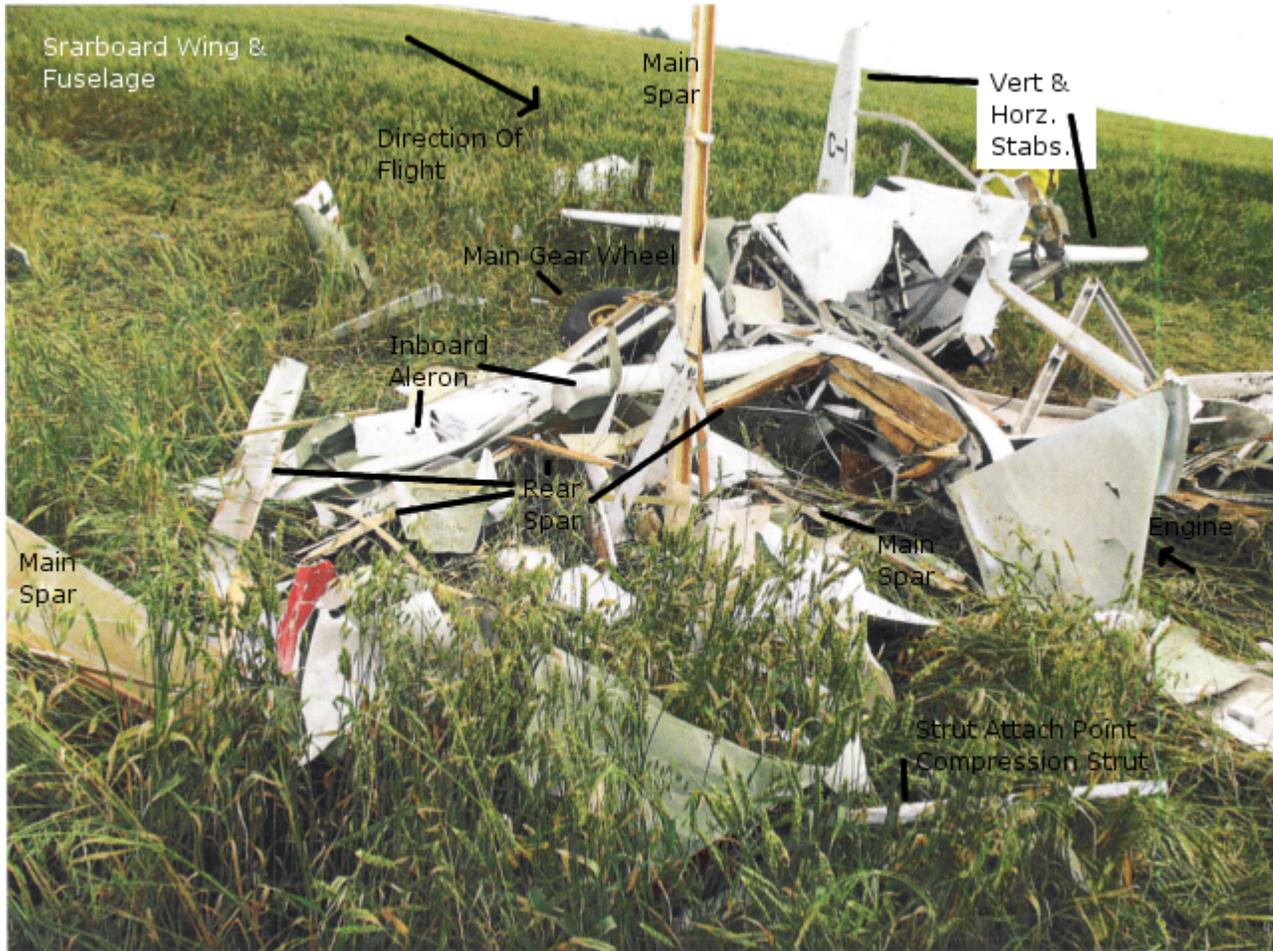
Starboard Wing & Fuselage.bmp

In the above photo, the main spar embedded in the ground can be seen (center). Ground penetration was somewhere between 11 and 16 inches.

The spar appears to be vertical in this shot but that is not really the case it leans quite a bit in towards the aircraft tail section as can be seen in the following photo.

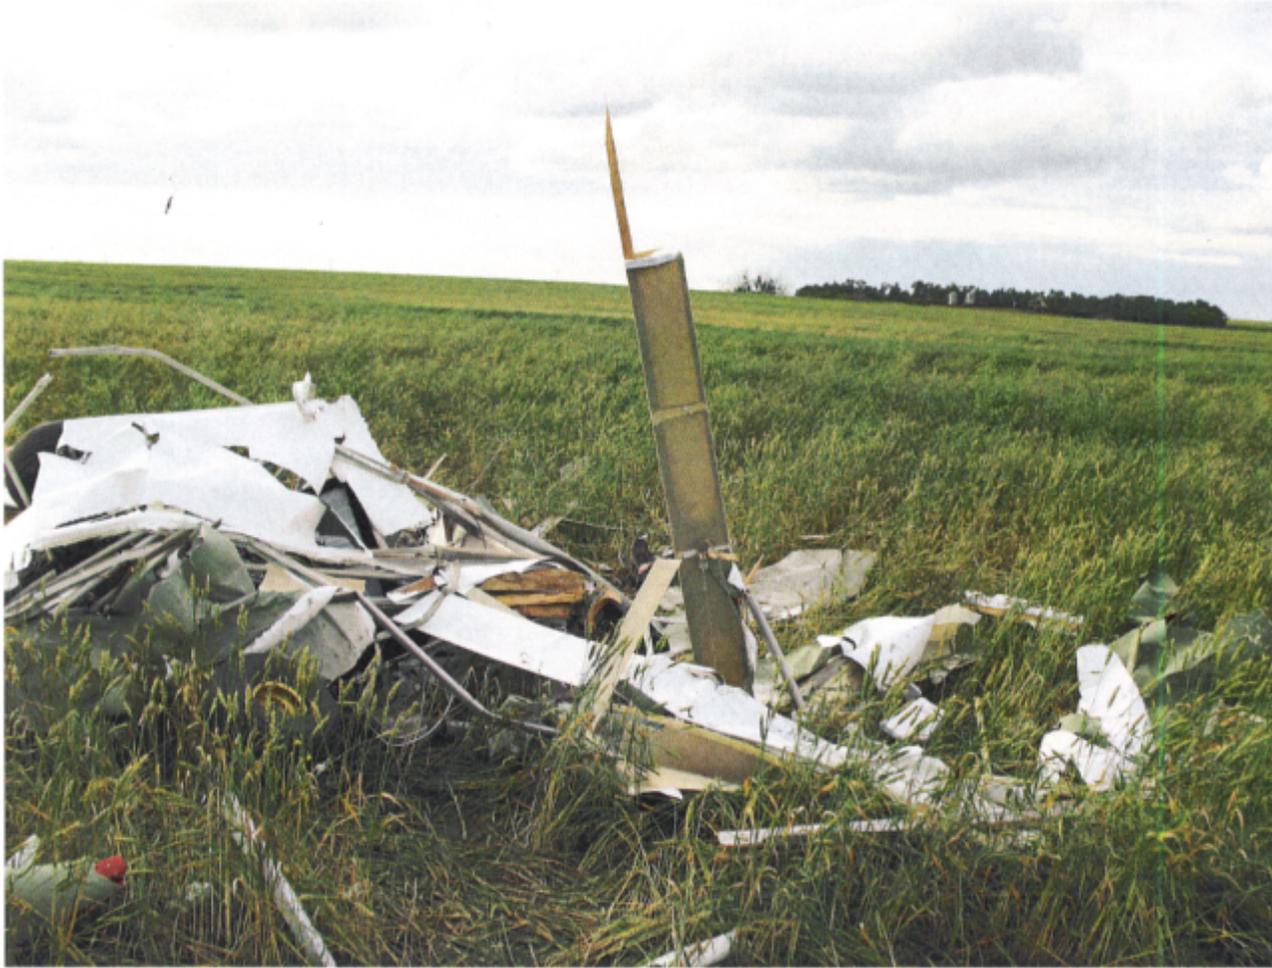
Site Starboard Rear.bmp

This location and position of this spar section has led T.S.B. to the assumption that the wing failed in flight. I have been studying the wreckage left behind by them and the photos of the sections that they removed for the past two+ months and I disagree.

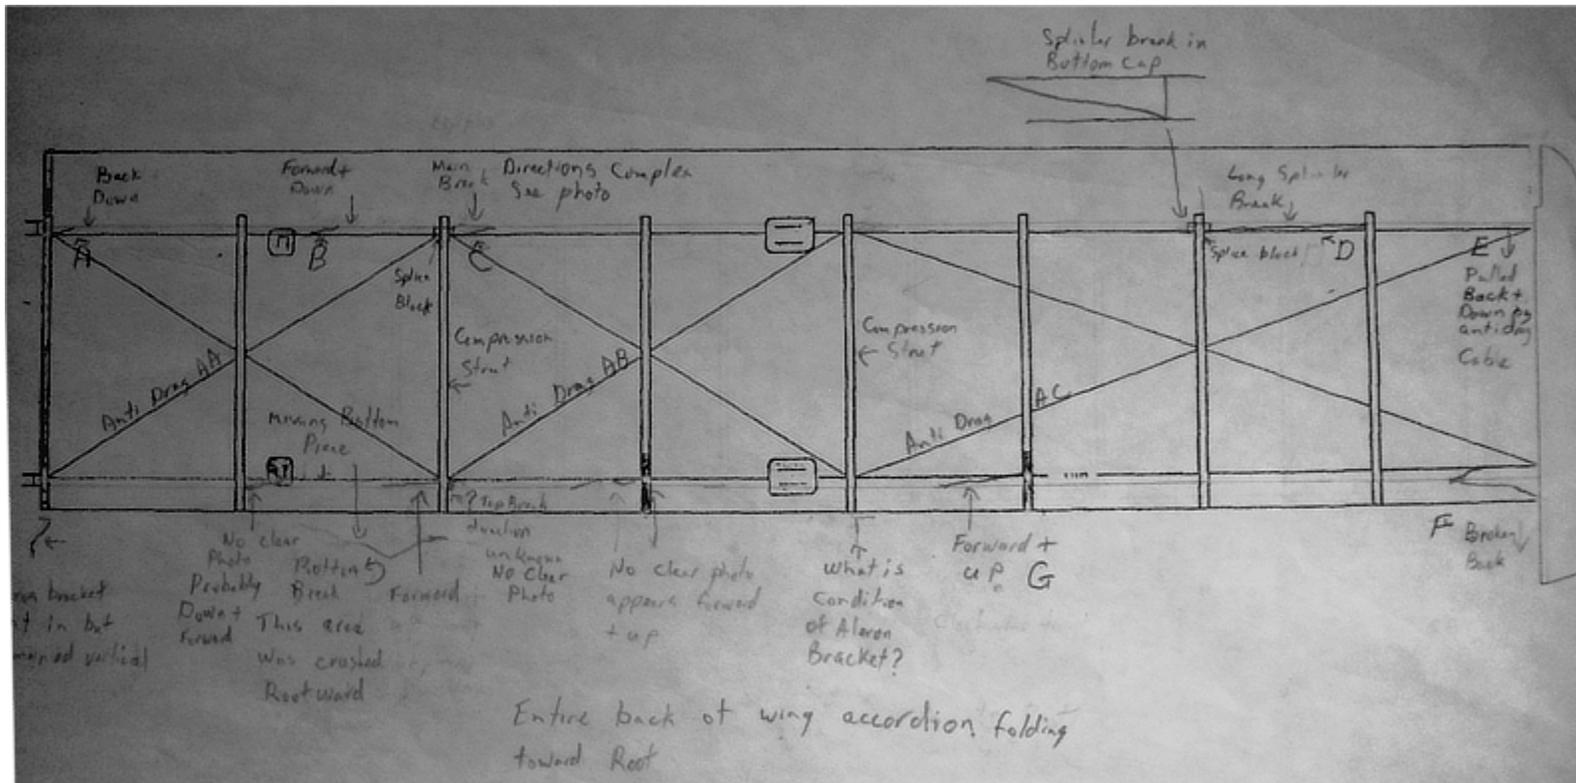
Starboard Wing Diagram.bmp

As the starboard inner rear spar was compressed by the port wing impact, the drag cable running from A to the rear spar would take the load (see schematic above). This would transfer energy forward into the compression strut at C driving it forward. The cable and rear spar were already under load from the drag of the starboard wing. This load was quit considerable due to the speed that the aircraft was traveling (Airspeed indicator was impact stuck at 94 mph.). The aircraft was descending (VSI impact marked at -1600 ft/min) and in normal flight at these speeds, the angle of attack on the wings would have been quite negative, more then -2 degrees.

The Rear spar collapsed under the combined loads between the root and the compression strut at C. The antidrag cable AA would normally divide this load back into the rear spar attach point, but the rear spar was now broken. Because of this the, compression strut at C drove through the front spar shear web breaking the splice block. This put load on the drag cable running from C to the rear spar past the rear strut attach point which tried to compress this section of rear spar. Combined with the port wing impact compression force running up the rear spar from the root the rear spar broke here also. The same likely happened to start the break at G.

As the engine impacted, fuselage motion would start to come to a halt along with the root end of the wing. The tip would still be trying to continue flying and antidrag cable AC would take the load. This force would transfer forward through the compression strut at the main strut attach points and be transferred down the drag cable connecting the rear end of cable AC to C. This would also cause the cable pull break at E.

The front end of the compression strut at C was no longer rigidly attached to the main front spar, so the spar would move forward and the compression strut back, tearing it's self out of the shear web and broken splice block. The cables AA and from A to the rear end of AA would still take load but the compression strut at C would now be just floating and it would collapse as soon as it became skewed enough.

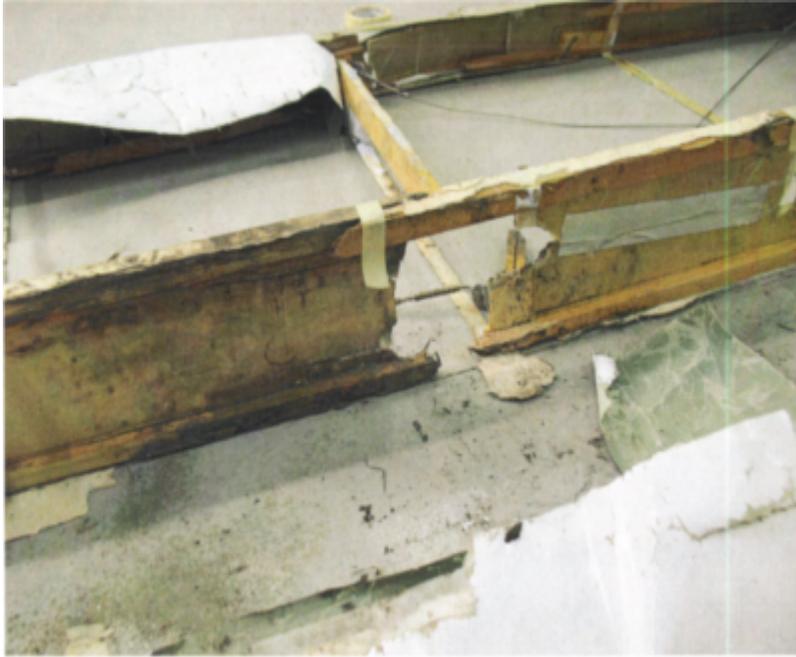
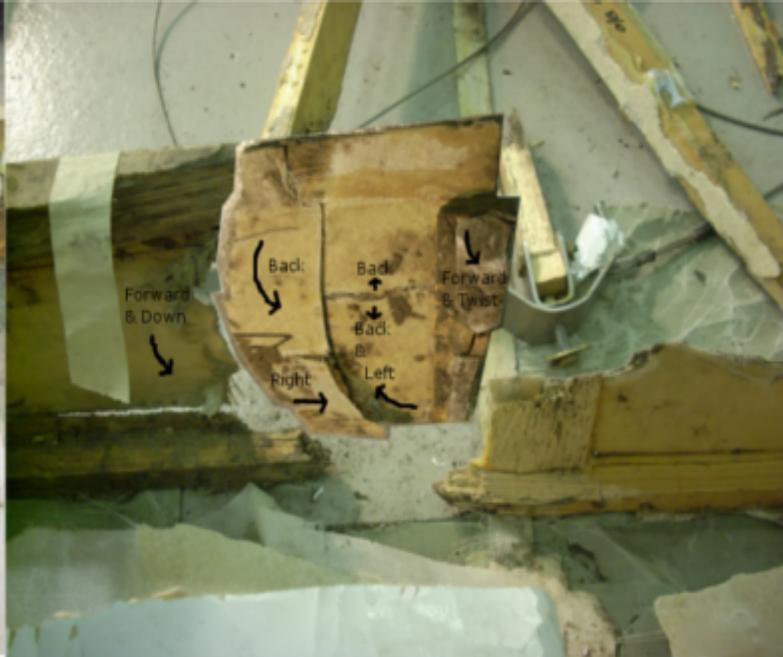
Main Comp.bmp

The main spar break is shown below left and a photo composite of the main break parts below right. The dark area on the spar on the far left is where it was embedded in the ground.

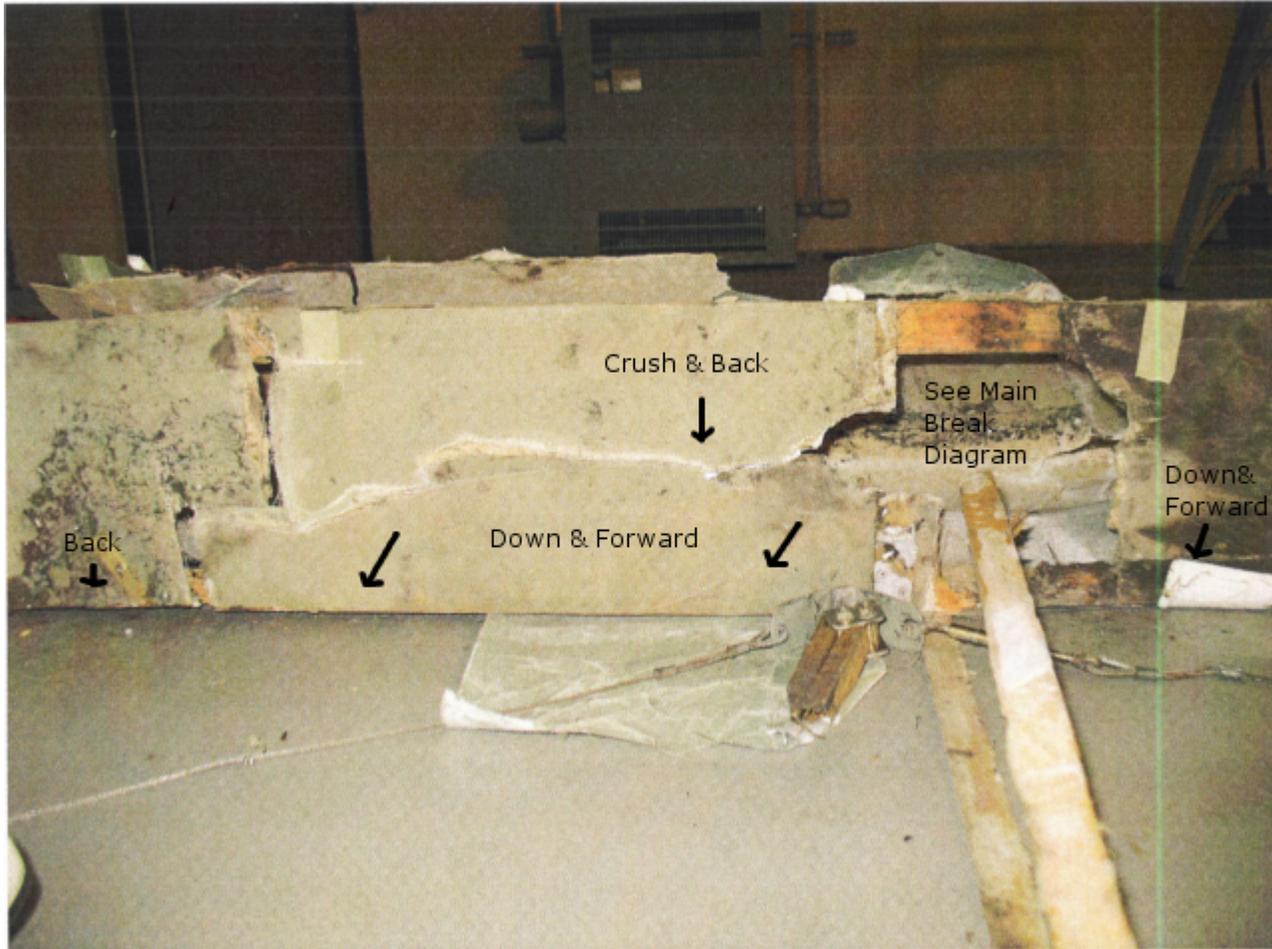
Both Main Breaks Back.bmp

Below is a view looking toward the front of the starboard wing from the rear, of the breaks at B, on the left, and C on the right.

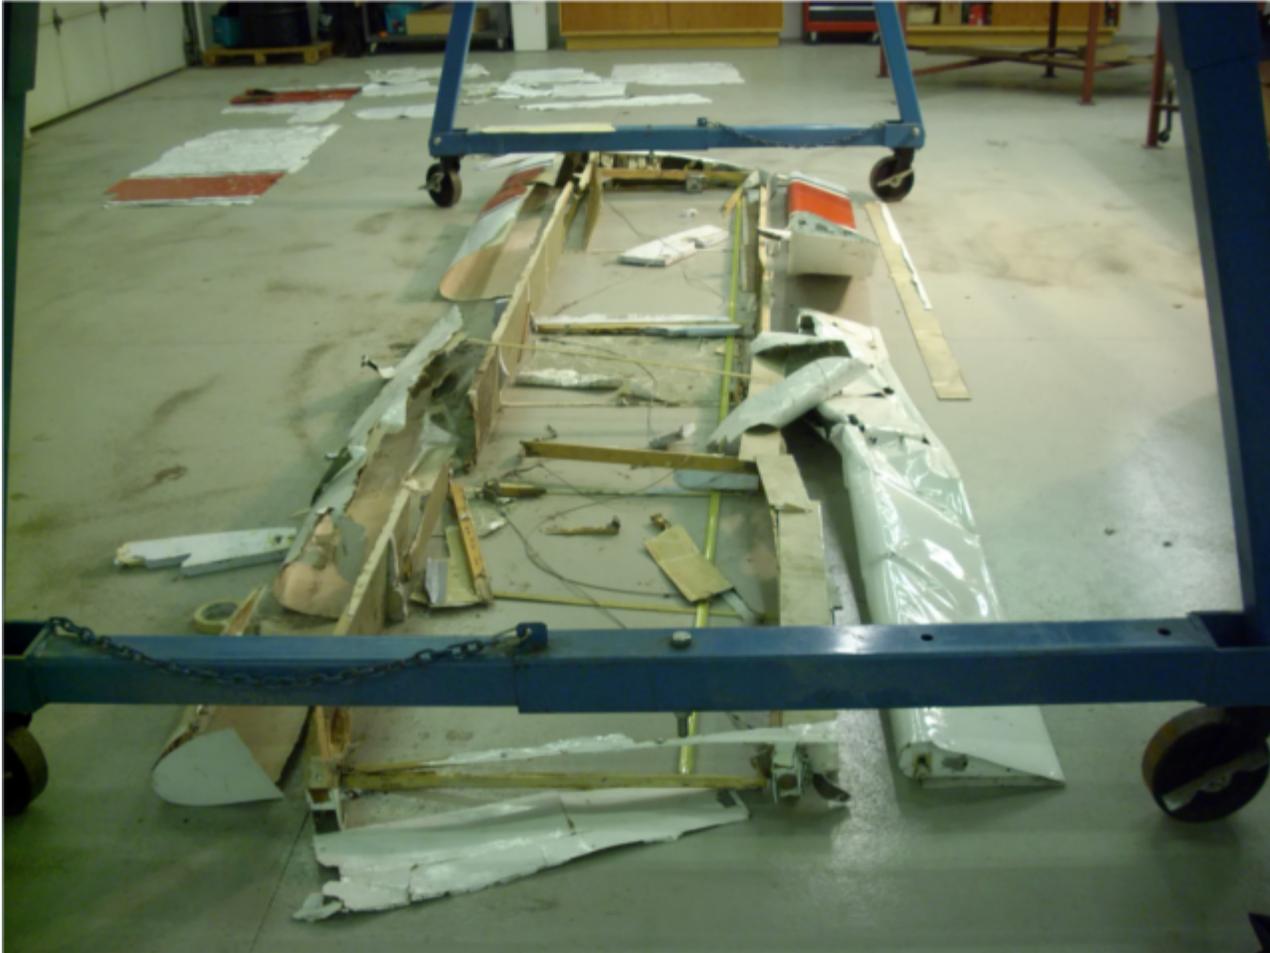
Starboard Wing From Root.bmp

Damage to the aleron is visible in the photos and would indicate that the aleron was at or near the neutral position at impact. This coupled with the same position on the port wing would indicate that the flap position must have been neutral at the time of impact.

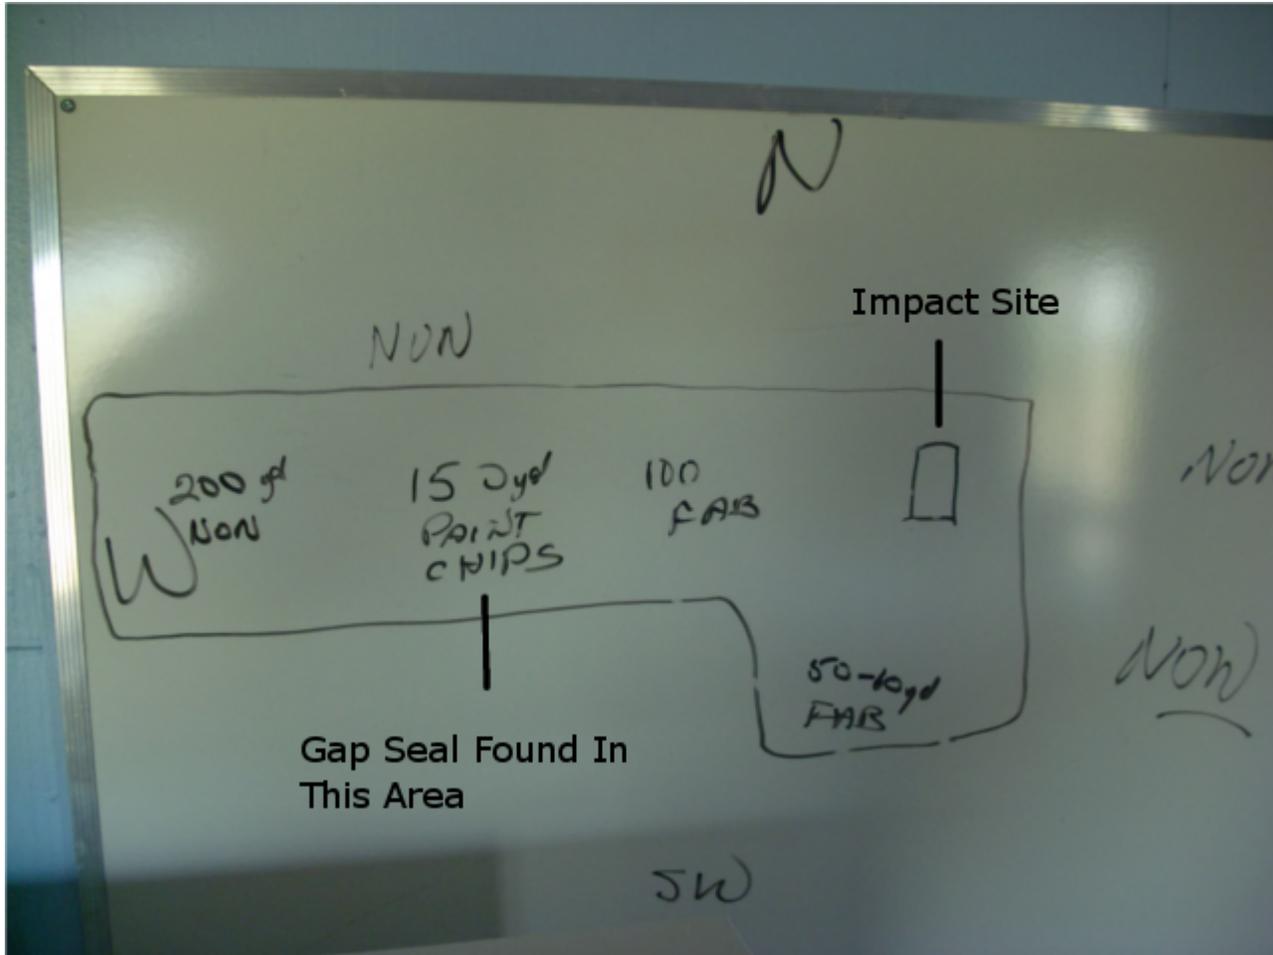
Site Diagram.bmp

The piece of gap seal described was found approximately 150 yds. west of the impact site followed by paint chips and then fabric.

The following photo is of a sketch done by a person helping T.S.B with the field search.
