To All Sylvaire Bushmaster and Husky Norseman Owners / Operators

From Gerry Golla / Corman Airpark December 2009

A possible serious problem with the wings of these aircraft.

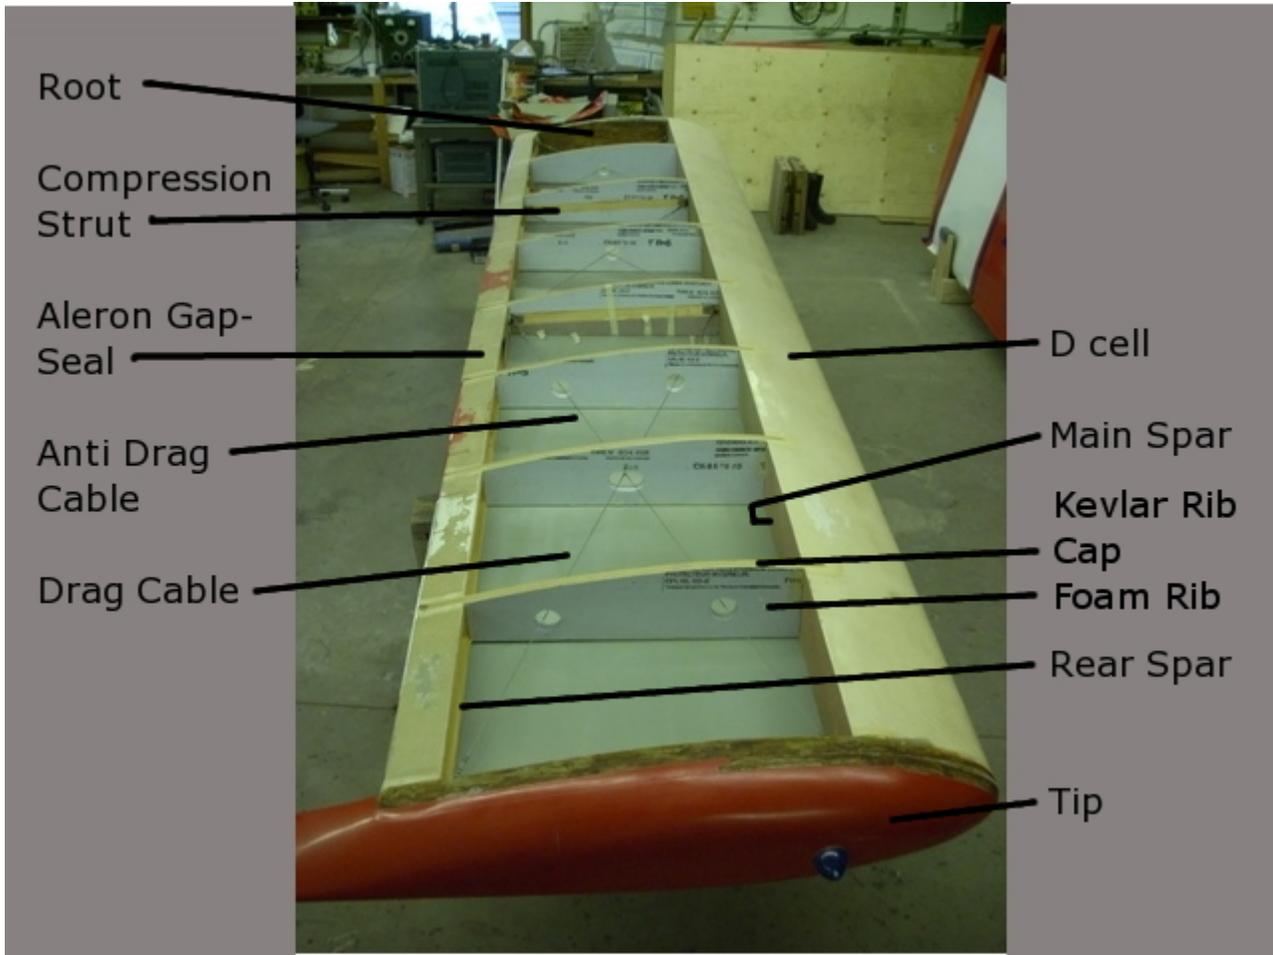
Labeled Wing Intact.jpg

In case you don't know what the gap seal I am referring to is, here is a diagram showing it.

The fabric on C-1AUE was NOT attached in any way to the rib caps. Once it started tearing there was nothing to stop it. They lost the entire top of the wing and the aircraft became unflyable.

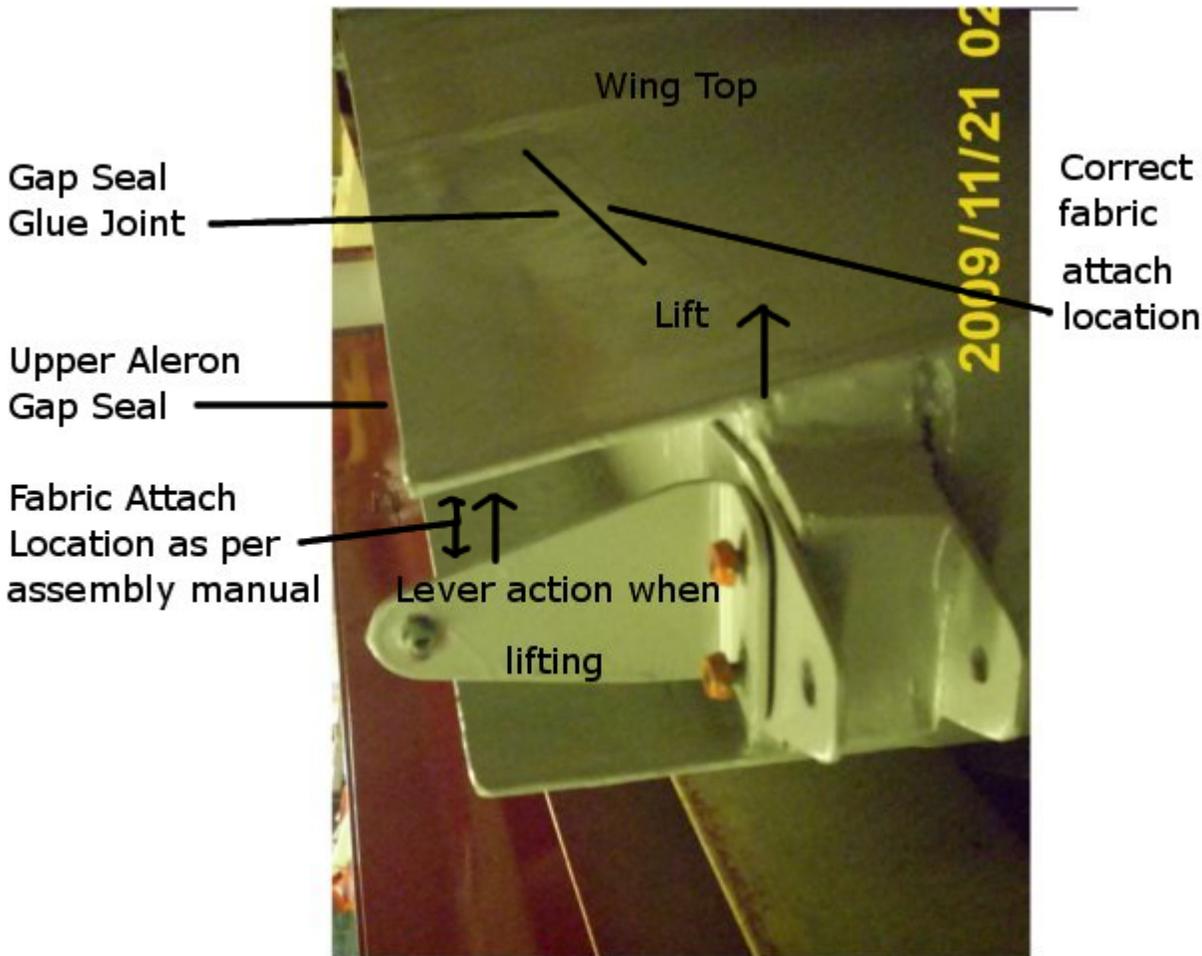
Labeled Gap Seal.jpg

If you picture the lift of the wing pulling upward on the top fabric of the wing and the fabric is not attached to the gap seal over the glue joint that holds it to the wing, then every time the wing lifts, the rear floating end of the gap seal is pulled upward by the fabric. The gap seal becomes a lever and it puts tremendous loads on the glue joint. This is not just a small pull either. Under normal flying conditions it amounts to close to 400 lbs distributed along the length of the gap seal. That is in smooth air and that is for EACH WING! Glue joints are only effective in shear loadings and this is definitely NOT shear!

Over time this stress on the glue joint will cause it to fail and the gap seal may start to show signs of separation. This separation can be difficult to spot, especially if you have no reason to be looking for it. The first indications of it are often warpage of the gap seal along its rear edge. This is the first thing to look for.

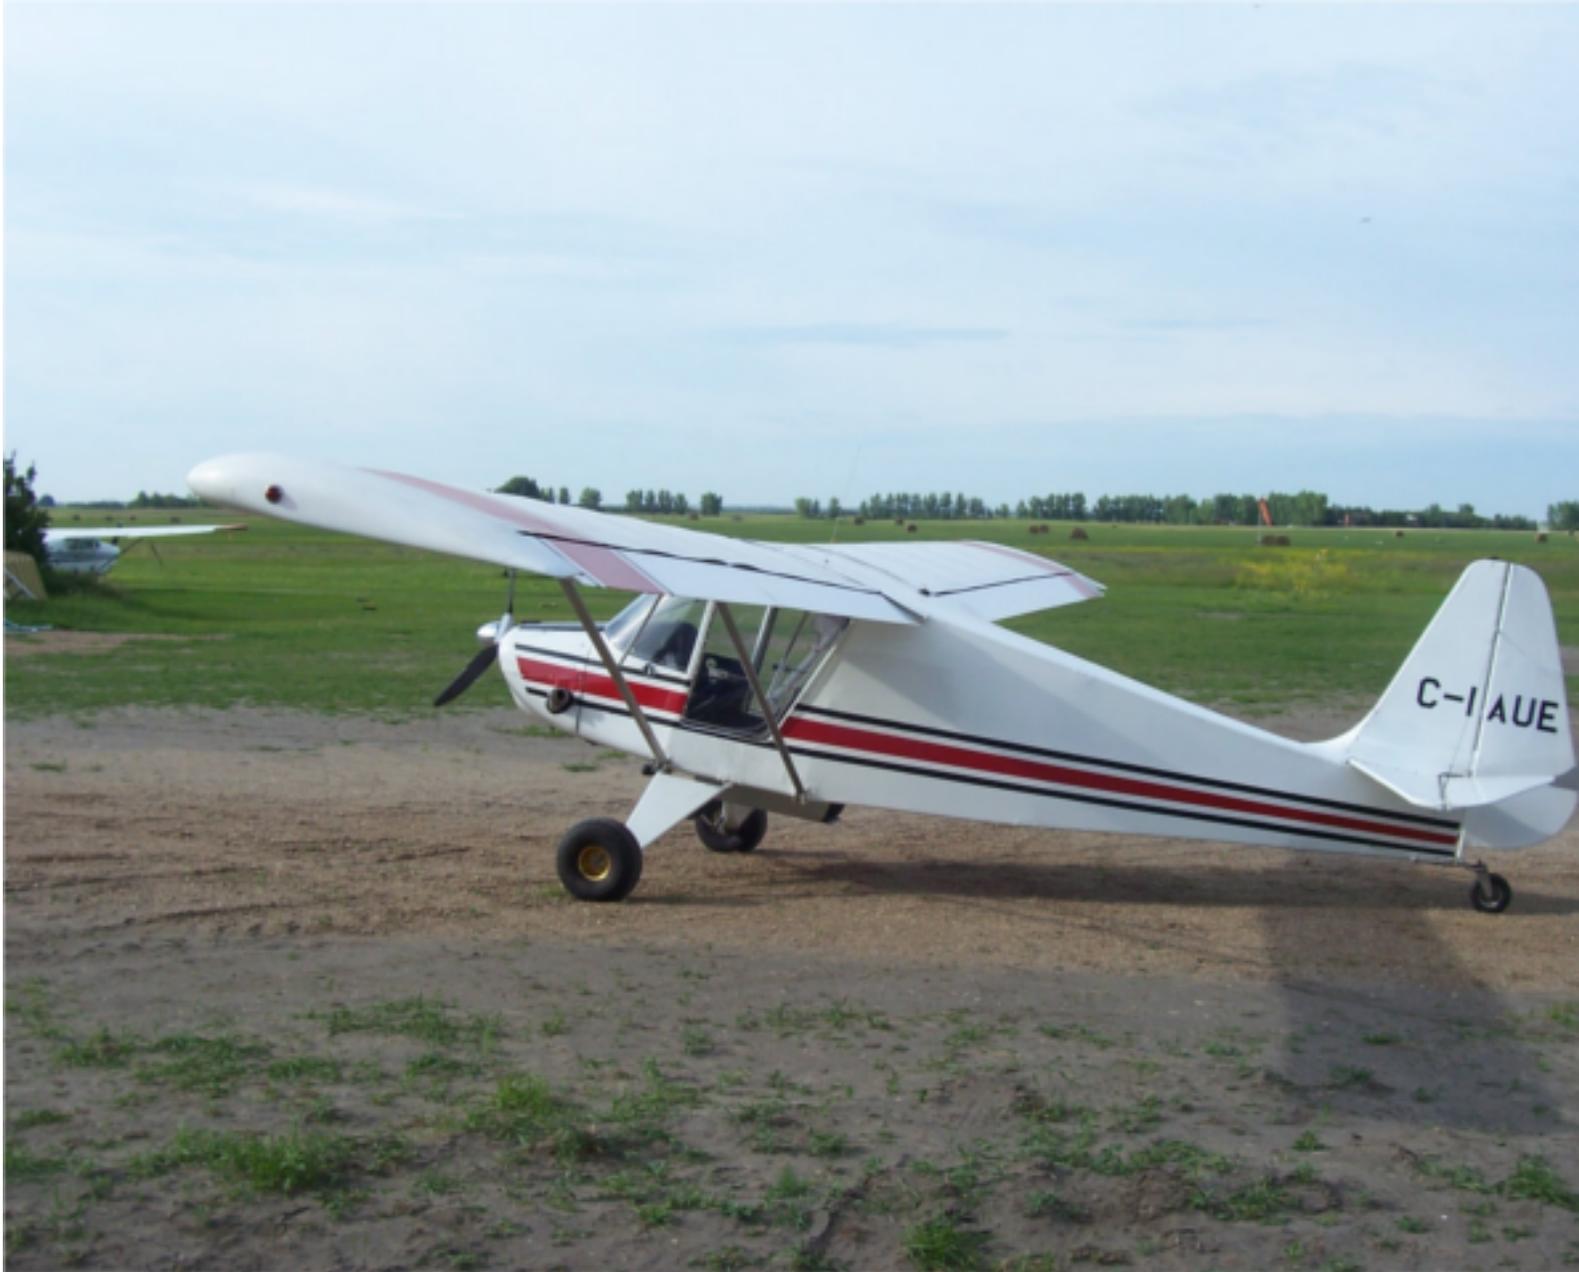
C-1AUE Stock.jpg

These gap seals dont look too bad, but you can see the waves in the ones on the left wing. This picture was taken about 2 weeks before the fatal crash. The starting point of the seperation is believed to be where the inner and outer seals join, just above the rear strut.

Next, take a coin, a quarter works well. Tap gently along the entire lenght of the gap seal, directly over its glue joint with the edge of the coin. It should sound solid over it's entire length. Hollow sounding spots are not good. You should check both the upper and lower seals this way.
