C-IAUE

Crash Cause Report

Copyright December 2009, Corman Air Park / Gerry Golla

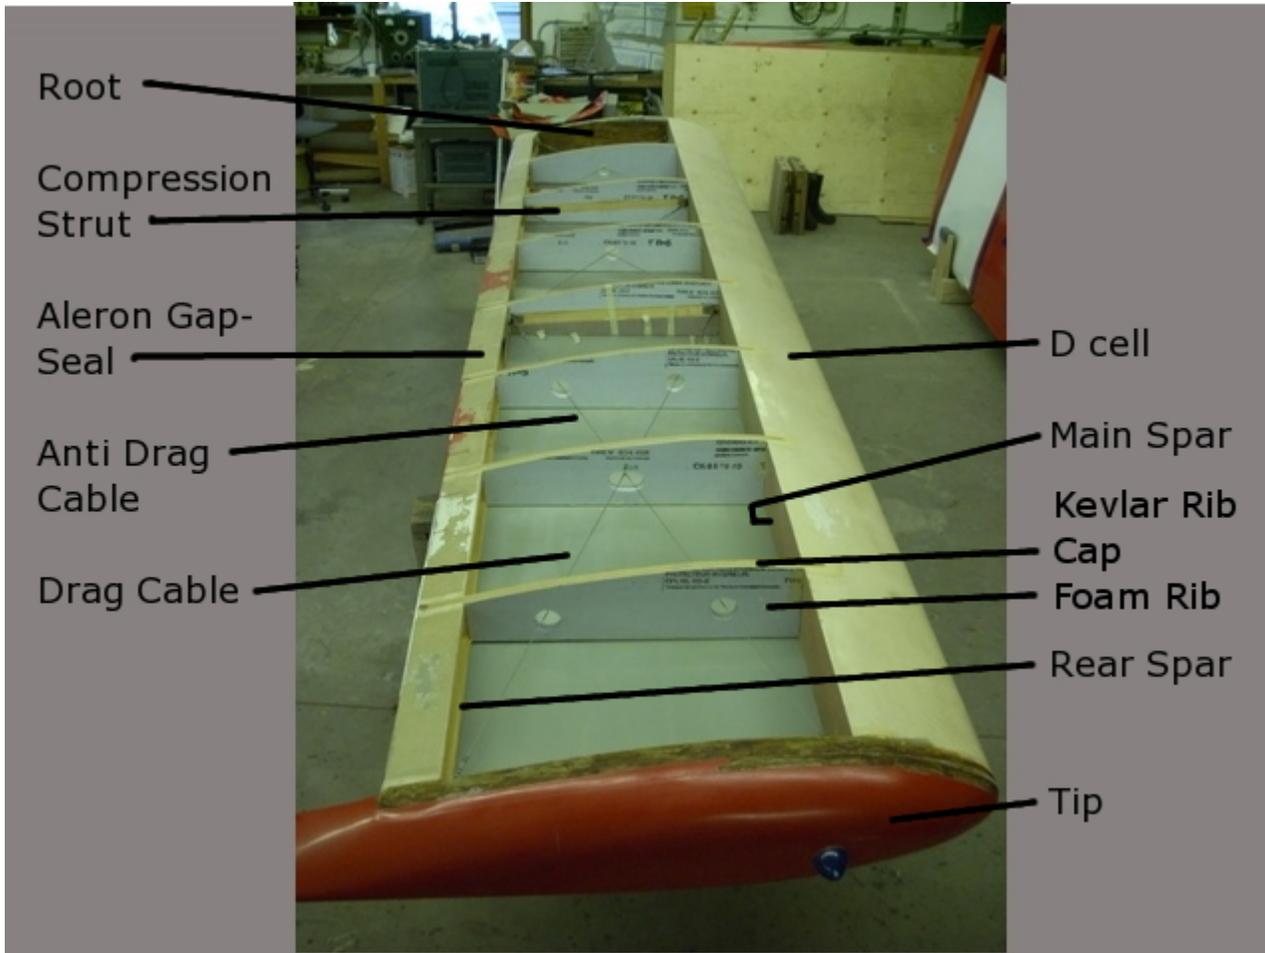
Wing Intact.bmp

This particular aircraft was modified to have the alerons double as flaps 'flaperons' and they were actuated by electric servo motors. There are only three known aircraft of this type that were built this way. The flaperons could also be set negatively, or up, to trim the wings for better performance at higher speed.

The actuation time for full travel limit to limit was alarmingly short, being just over one second under no load. Both servos were found in the fully extended or flaps down position.

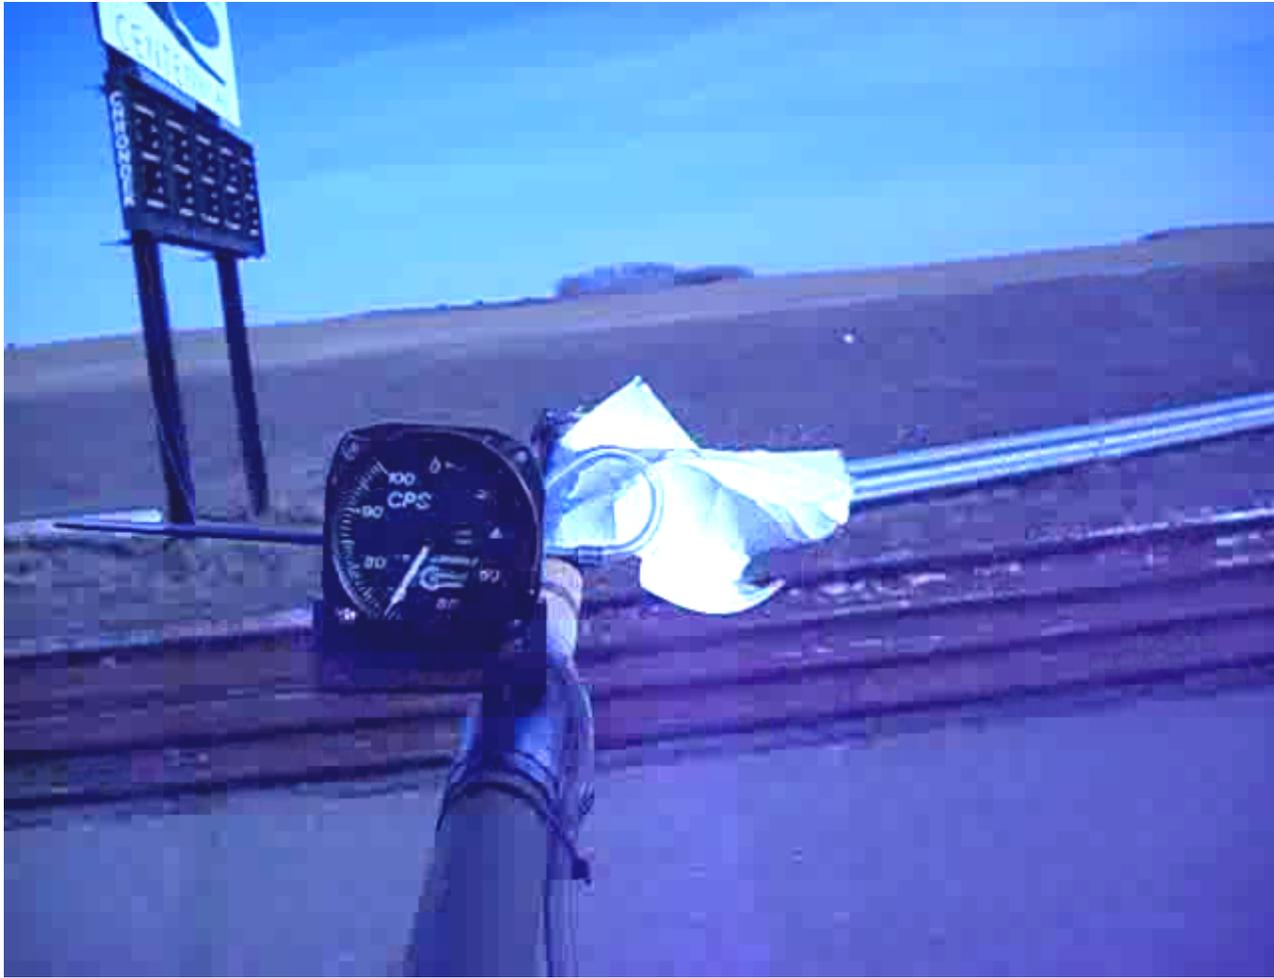
Fabric Test.bmp

Tests were run to try and determine the time frame required to cause flaging to a piece of fabric removed from the top of the aircraft fuselage. These tests involved attaching a piece of fabric to a test jig equipped with a airspeed indicator and camera and pushing the fabric into the airflow outside of a vehicle opperating at a closed track (local dragstrip).

Unfortunately, the track proved to be too short to achieve significant exposure times at high speeds and the test results were inconclusive. They show only that significant flaging would appear to take more than just a few seconds, higher speeds, greater turbulence, or a combination of all of these.

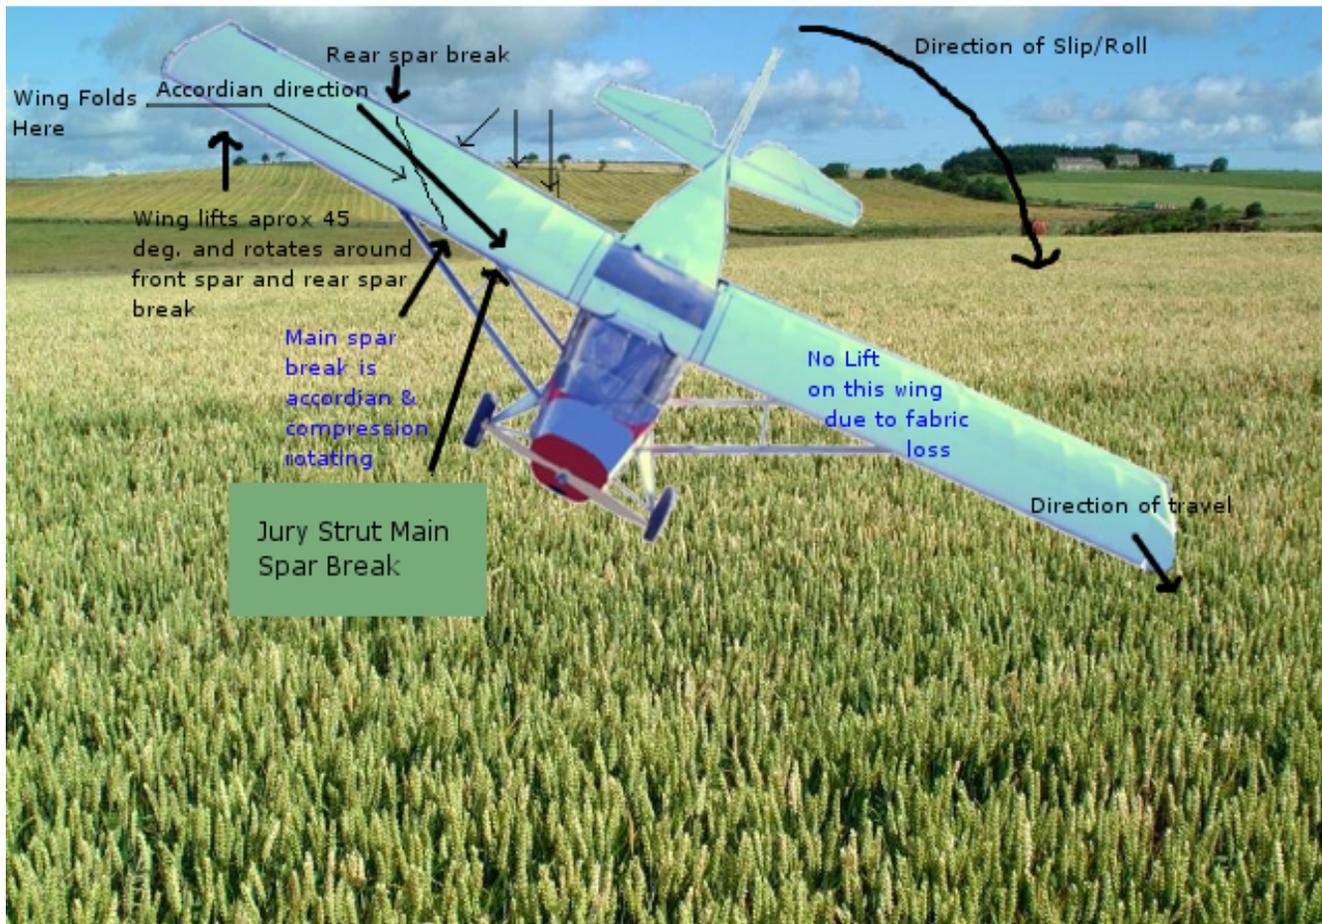
Pre ImpactRW.bmp

The instantaneous deceleration forces on the starboard wing would greatly exceed it's lifting forces at this point (lift was probably less than 600 lbs.) and the wing levered down on the front main strut. At the same it time started to swing forward and force it's self rootward at the leading edge because of the direction of the aircraft roll/slip and the energy transferred from the port undercarriage and the starboard wing forward/slip inertia (kinetic energy).

As the impact progressed, the lower main spar cap was put in compression and the top cap was put in tension. This is the reverse of what the caps were designed to carry. The lower cap could not carry a lot of compression energy without fracturing. (The wings were only rated at -3 g's. when completely intact).
